NSMBA TAP Trail Assessment/Work Plan

Trail Maintainer: Sean Gerke
Trail: Boogie Man
Proposed Date to complete below work: TBD

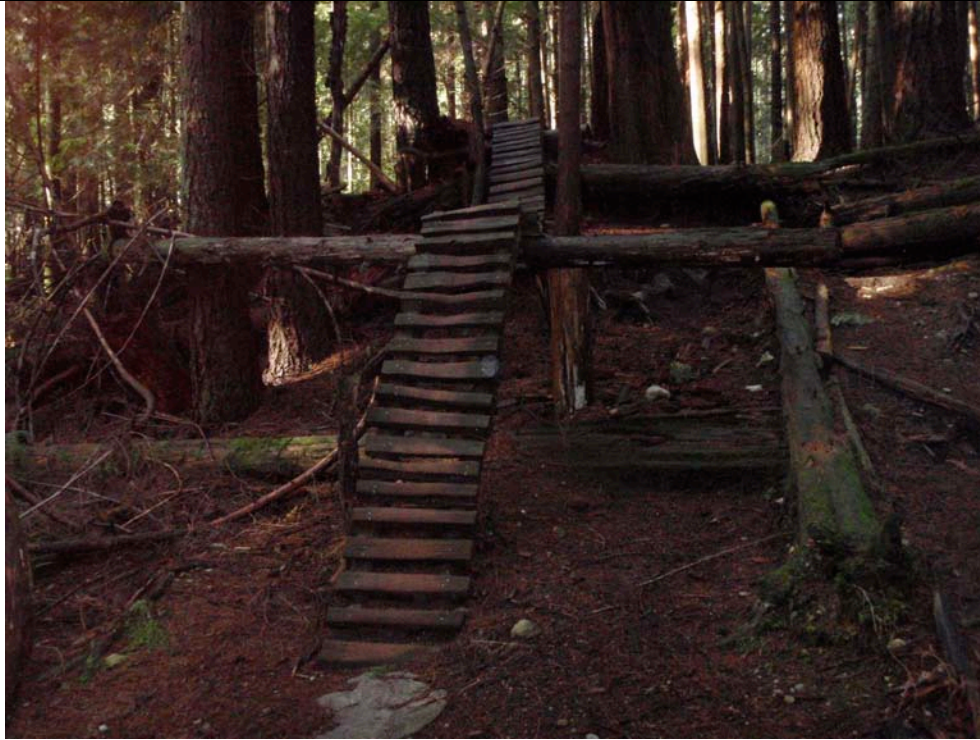
The two original sections for this feature remaining are in need of replacement. The stringers are rotting and rungs are too small and the section is partly supported with one end of the support being nailed into the tree on the left.

Solution: Replace sections with a freestanding structure with bigger stringers and thicker rungs from cedar on site.

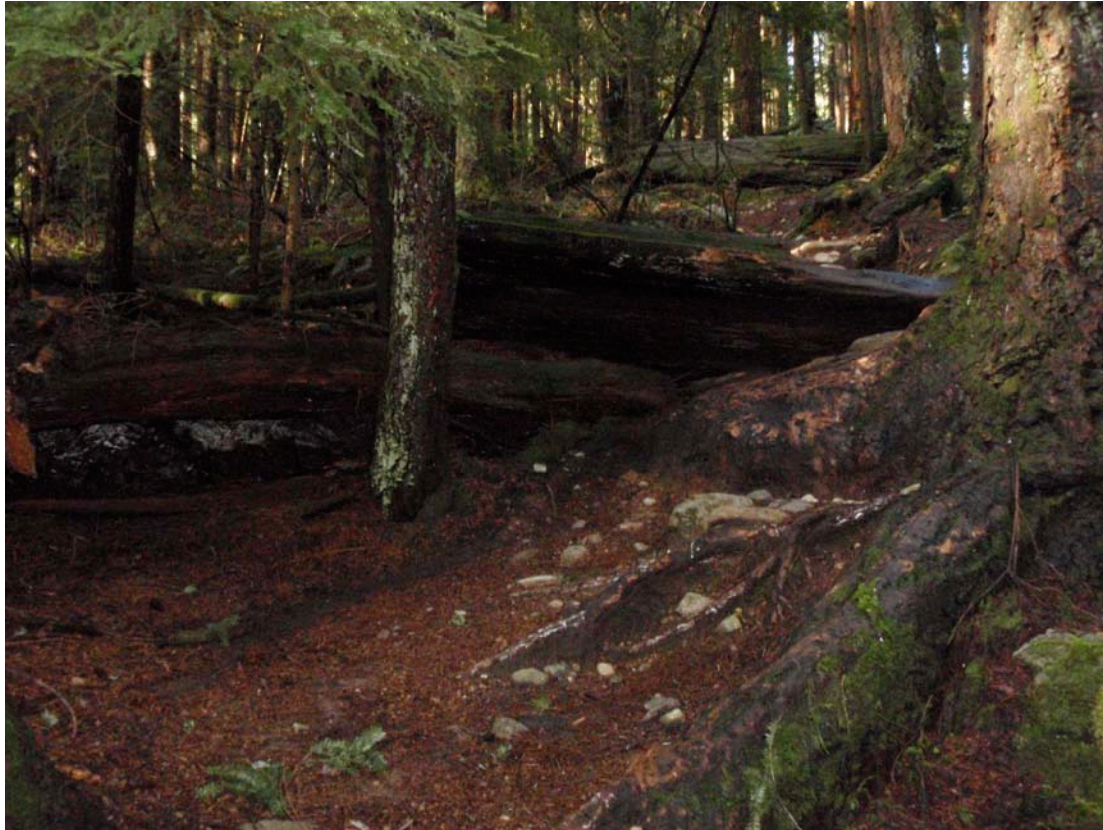
The ride around is tight, with deadfall right beside the rider. The roots are getting more exposed and would benefit from protection.

Cut out deadfall

Either rock armour corner or build ladder bridge corner.

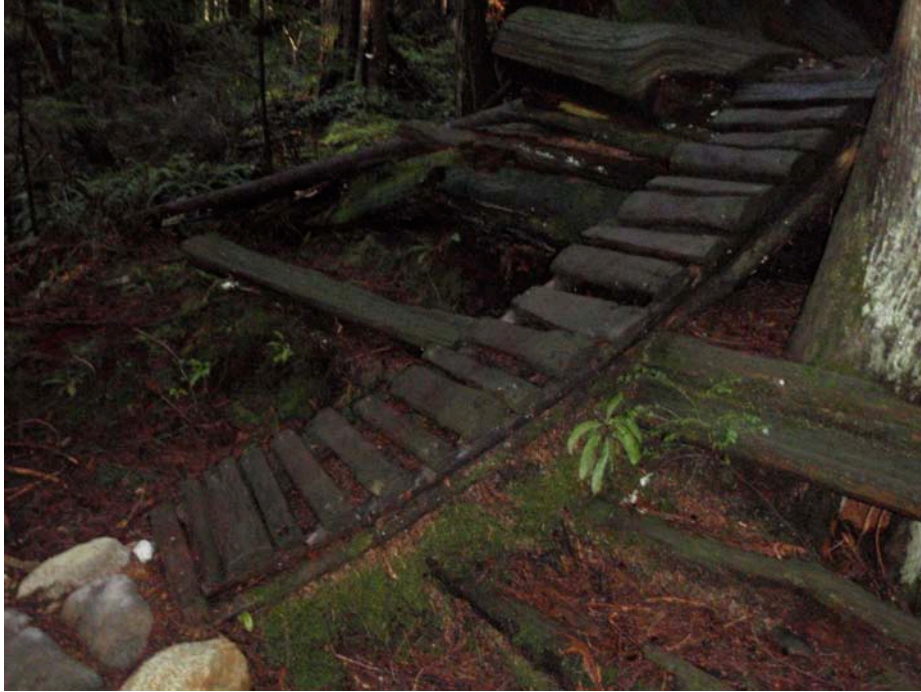
Describe Problem: Stringer supports are rotten and too small. In addition rungs are too small or missing.

Solution: Replace with bigger stringers and rungs from cedar on site.

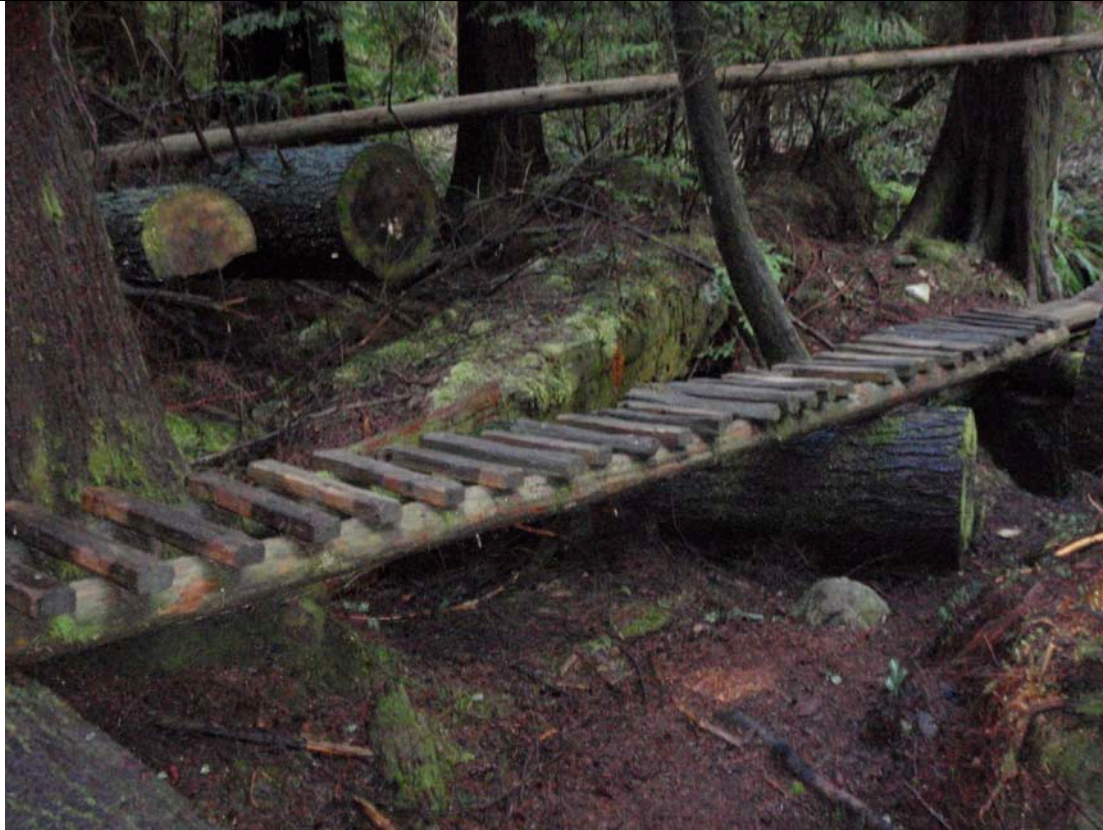
Describe Problem: Stringers are rotting and rungs are too small. Rungs offer poor traction because they are treated wood.

Solution: Replace bridge with better support, bigger rungs from cedar on site.

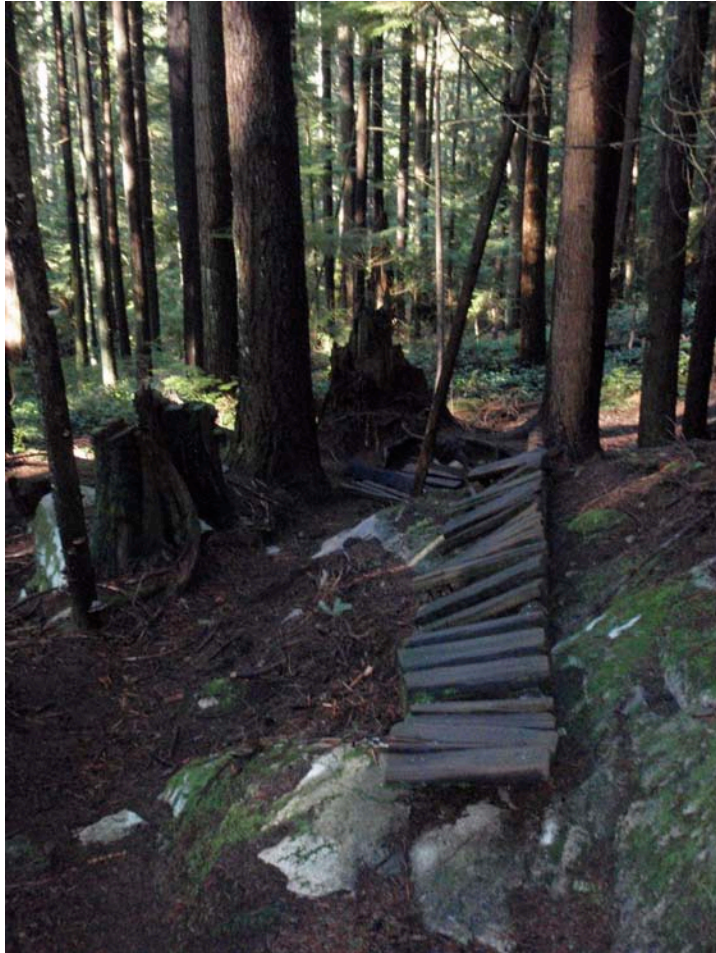
Describe Problem: Stringers are broken and bridge has been moved to side of trail.

Solution: Replace bridge on original line to the left of where the bridge sits in the picture above. Cedar found on site.

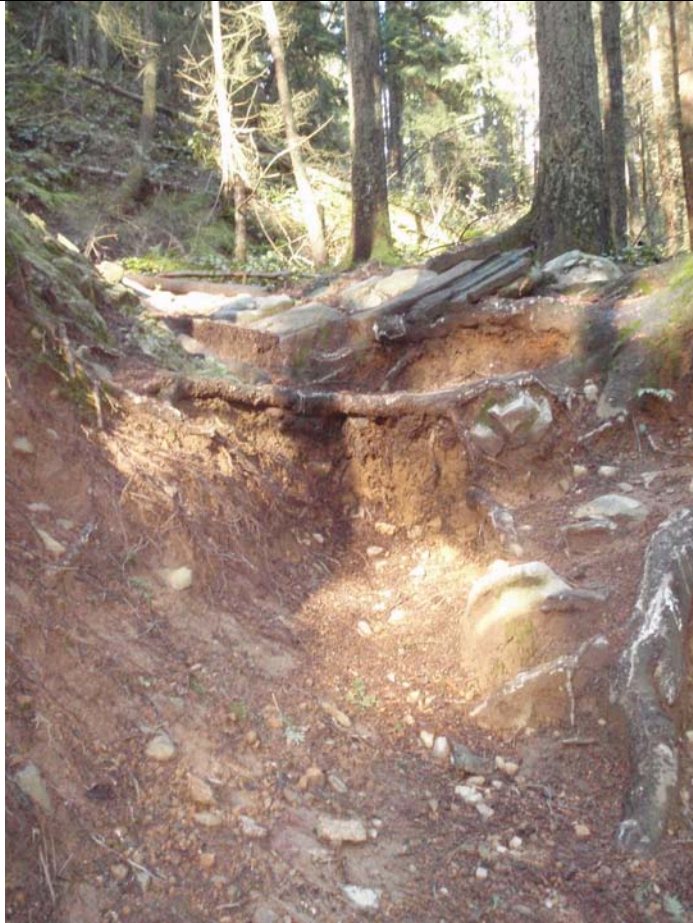
Describe Problem: The ground level has eroded away by about 2 feet over time.

Solution: Build a crib and rock armour

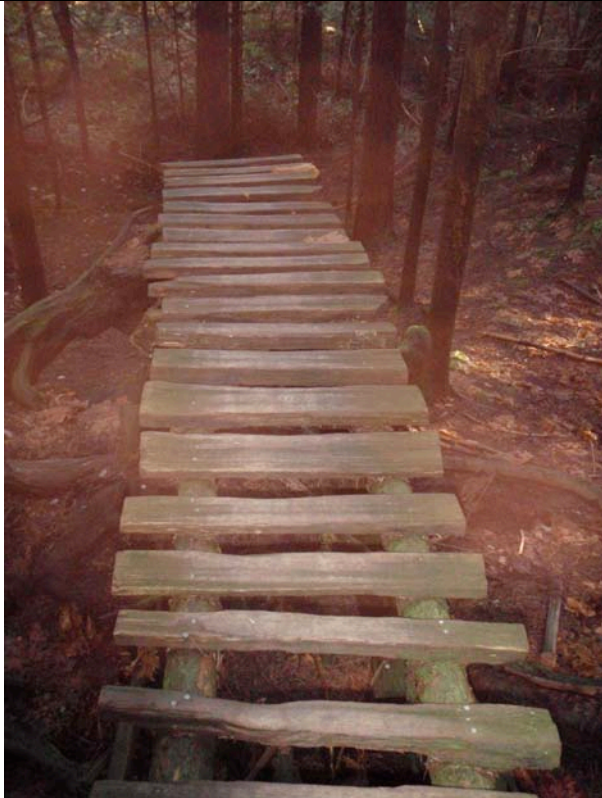
Describe Problem: Stringers on the original section of the pile driver are in need of replacement as well as some of the support posts

Solution: Install new Stringers, rungs & support post. From cedar found on site.
