TRAIL ADOPTION PLAN

2012 Assessment/Work Plan

Trail: Pingu

2012 TAP Trail Assessment/Work Plan Pingu

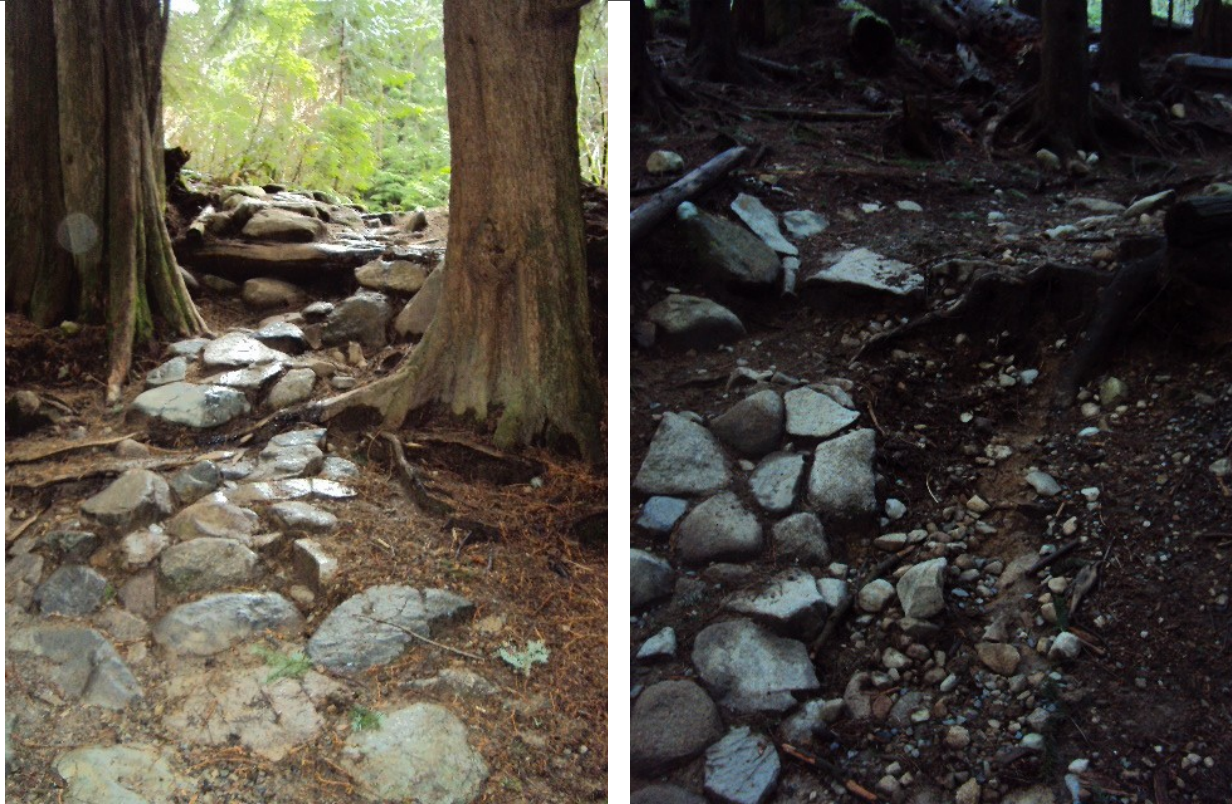
Describe Problem: Entrance is severely eroded and straight fall line requiring heavy braking which further degenerates the heavily eroded trail bed. Old armouring is chunky and has shifted over time making navigation a challenge. User experience is poor and riders are creating a new loam entrance.

Solution: Trail needs realigned for proper drainage and to lessen impact on trees. Bench landscape approximately 50 feet above existing entrance will rectify alignment and degeneration of impact. Reclamation for old trail bed.

Approximate timeline: 2 trail days.

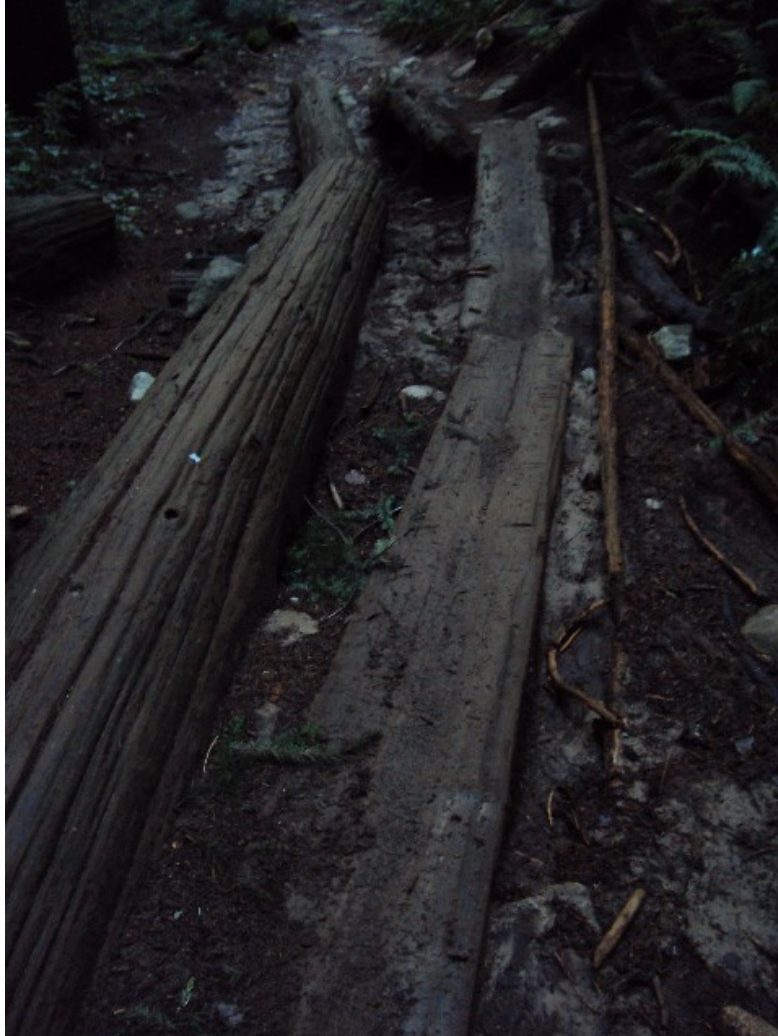
Describe Problem: This section is misaligned and the woodwork slippery. Combined with the fact it is a high speed section requires a solution to mitigate risk.

Solution: Wood needs to be removed and trail bed raised with rock ballast and covered with dirt.

Approximate Timeline: 1 day

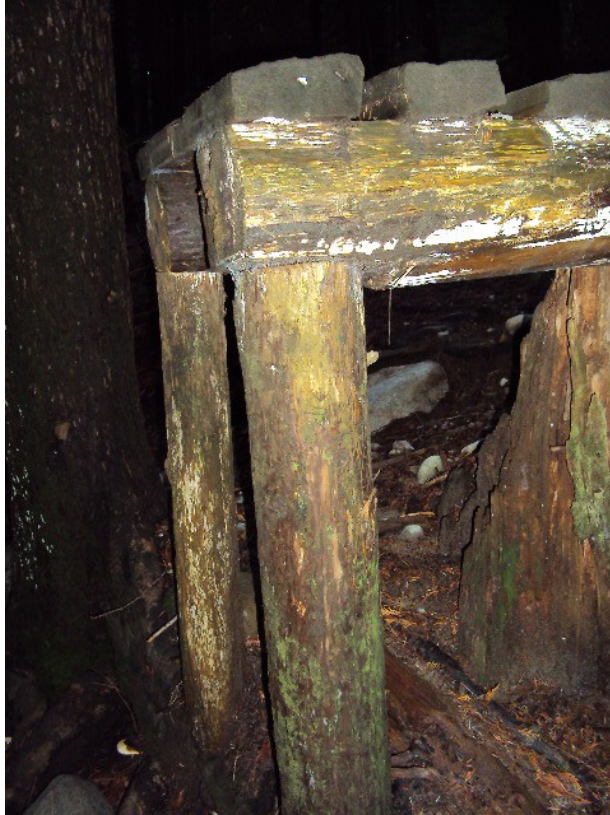
Describe Problem: Wood structure is beginning to rot as evidenced with cracking of stringer and fungus starting. The platform drop is at the end of a high speed fall line section - the stunt doesn't match the entry speed and riders overshoot to land on flat area without transition.

Solution: Platform needs to be repositioned to match entry speed in conjunction with landing slope for proper transition.

Approximate Timeline: 1 day

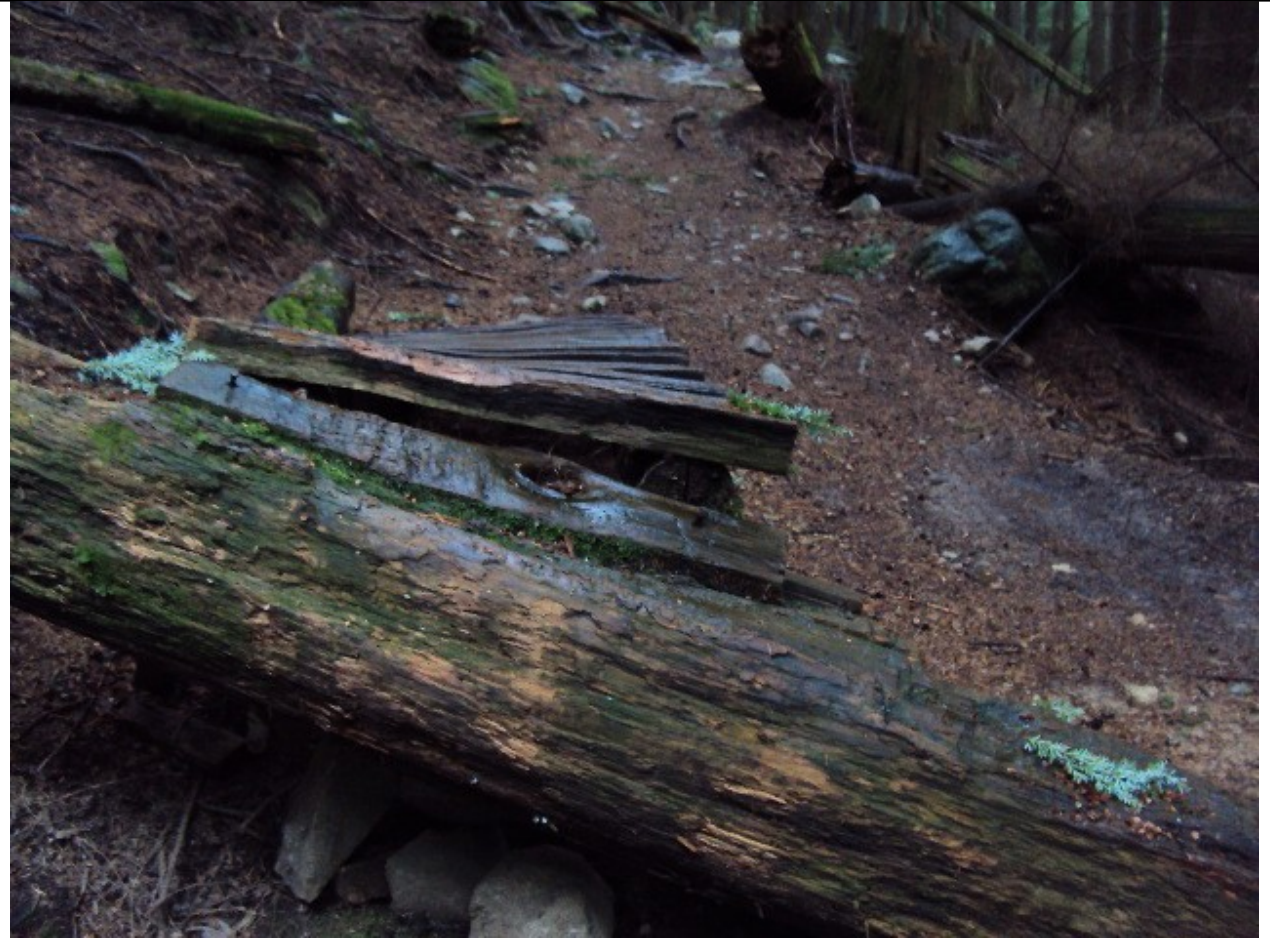
Describe Problem: Stunt has twisted over time and is off camber in the middle of a high speed section.

Solution: Stunt needs removed and log cut out.

Approximate Timeline: 0.25 Trail day

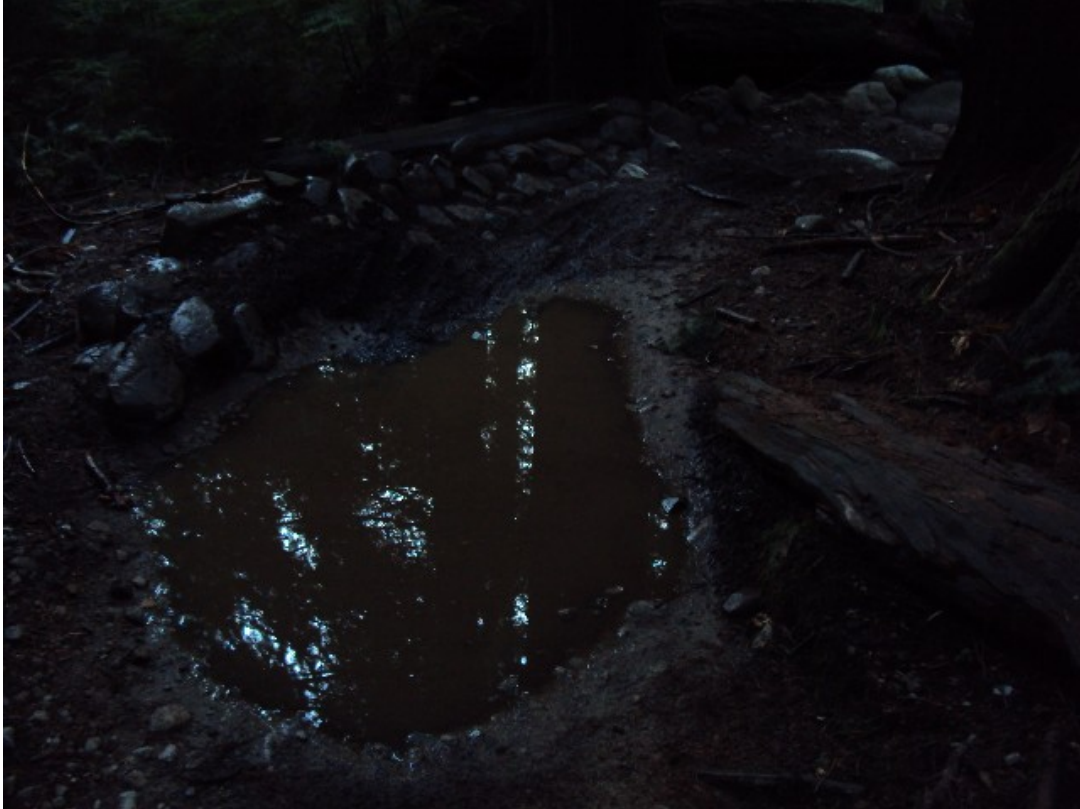
Describe Problem: Drainage

Solution: Trail bed needs built up and drainage rectified and dirt put on banked corner.

Approximate Timeline: 0.5 day

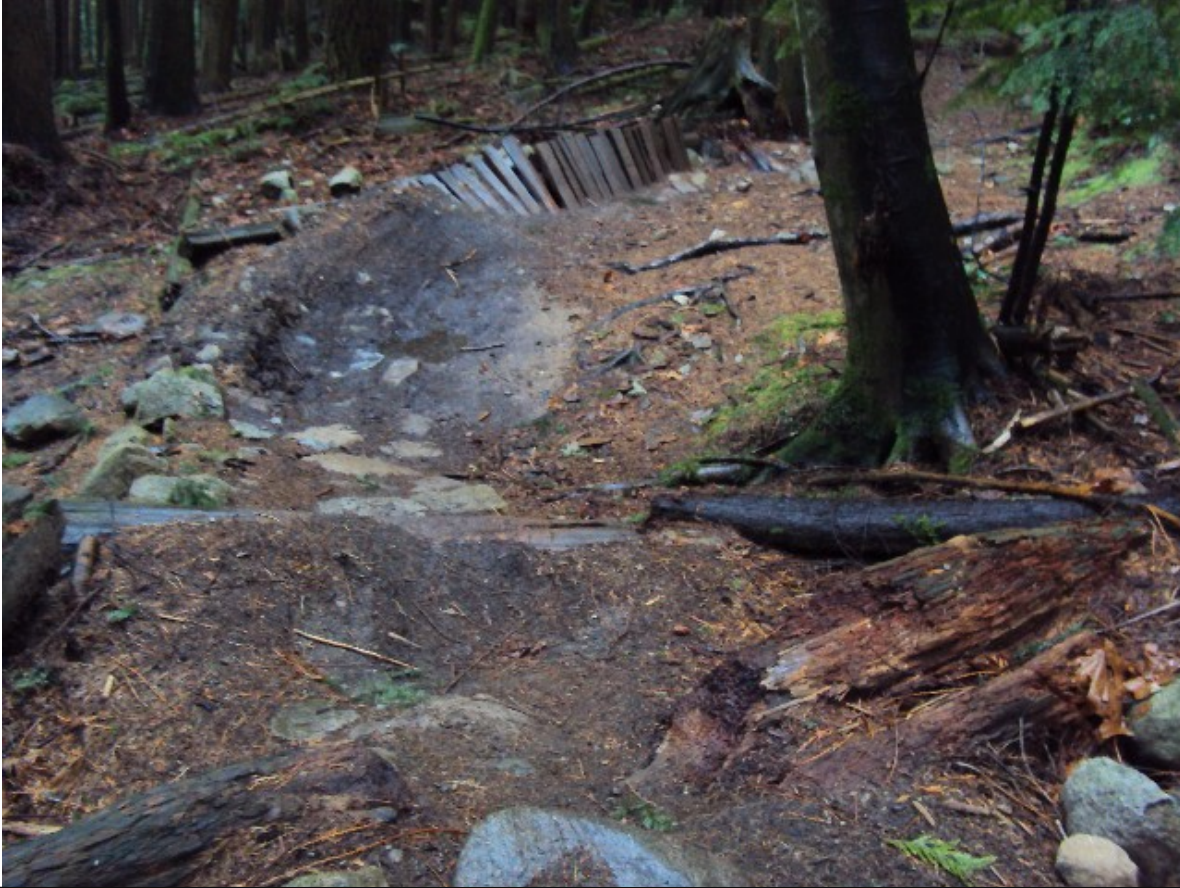
Describe Problem: Water is trapped in low area. This section has a poor user experience and the combination of speed into a sharp turn further impacts the low drainage area with braking forces.

Solution: Trail needs realigned on the high side of the tree on the right.

Approximate Timeline: 1 day

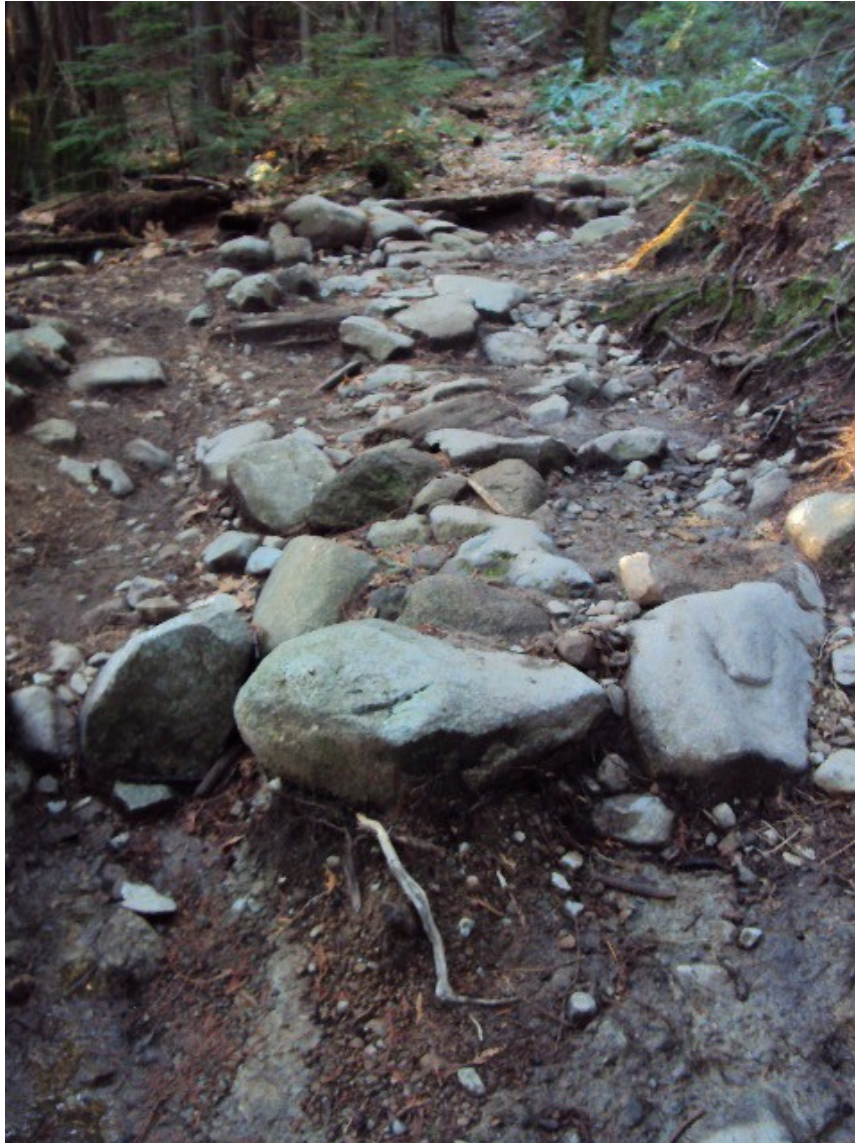
Describe Problem: Trail exits onto fall line, severely eroded Incline hiking trail. Unsustainable, advanced erosion, poor user experience and user conflict. The trail is more a creekbed with water flowing freely down it.

Solution: Trail needs realigned to exit at Pangor.

Approximate Timeline: 3 days
