TRAIL ADOPTION PLAN

2012 Assessment/Work Plan

Trail: Lower Oilcan

Trail Adopter: Dizzy Cycles

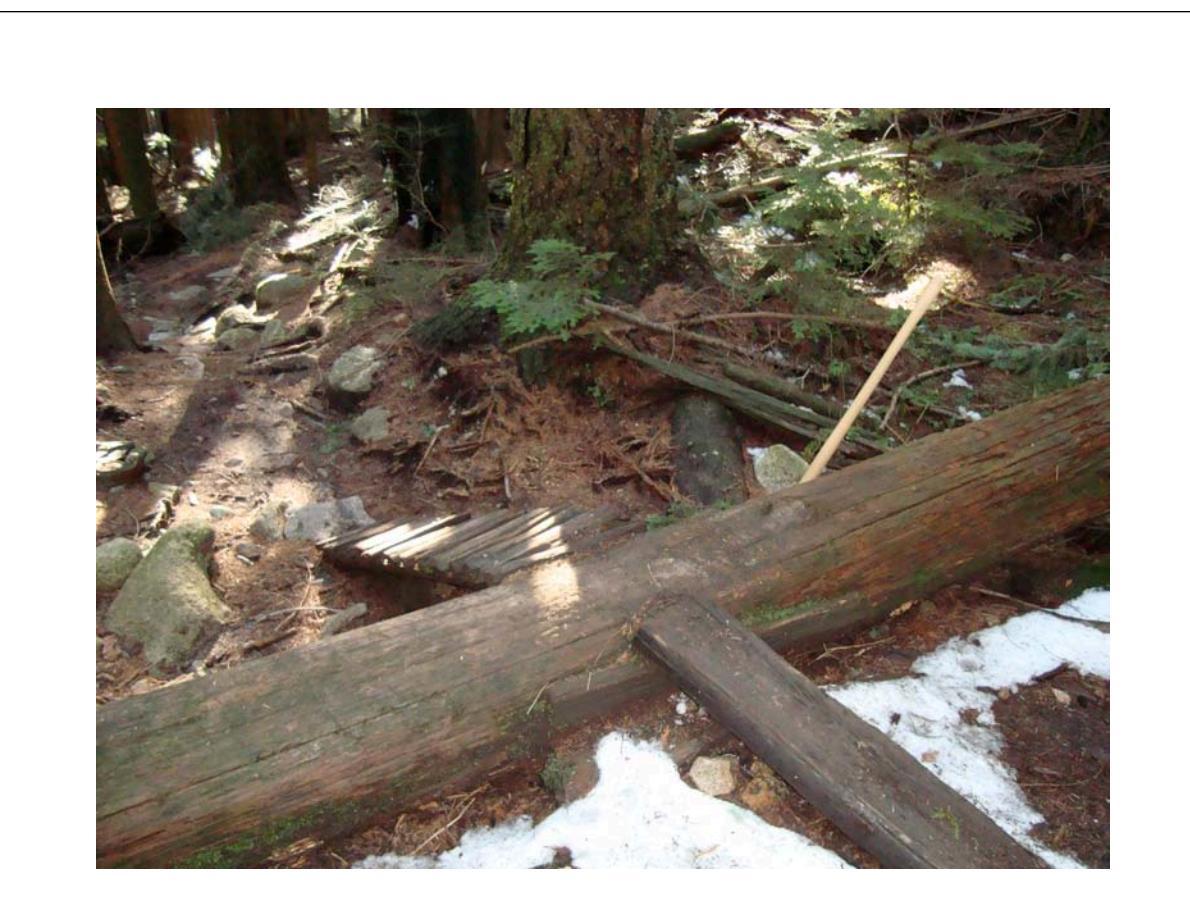
Problem: Awkward skinny ramp over log manoeuvre onto rickety down ramp and rocky outrun with soft sections.

Solution: Clear existing drainage and re-establish line. The wooden transition ramps are to be removed because they are rotting and the log must be rebuilt up to on both sides with rock and dirt. The dirt will be smoothed out and reshaped to allow drainage. We will also add a roller grade reversal 3-5meters down from the log to slow riders down before the corner. Reclamation and narrowing of old trail tread to reduce trail impact.

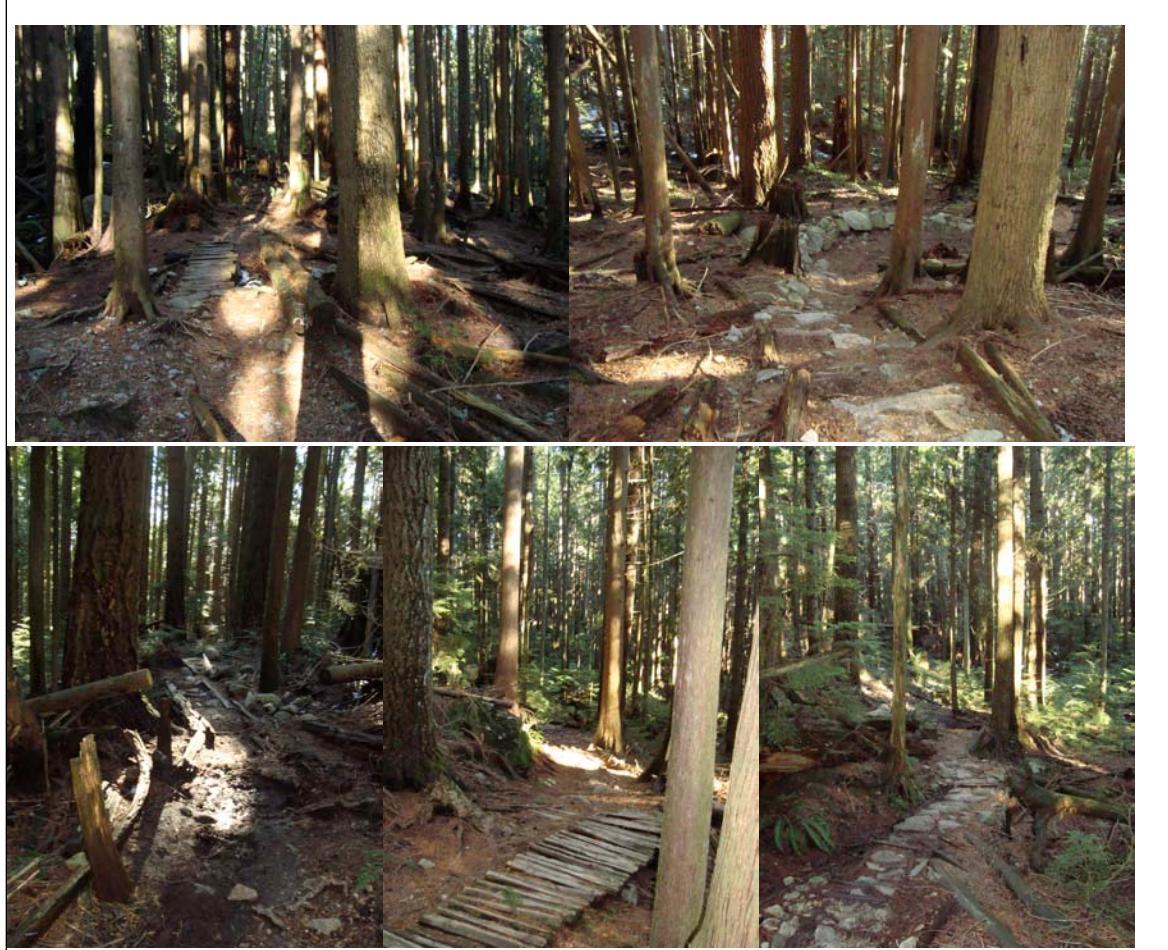
Problem: Lack of alignment and maintenance has expanded the trail tread. Corners are built with poor shape and correct entry point is difficult. Trail railing and bad TTF alignment has caused trail creep and erosion.

Solution: Rebuild sequence of corners to allow more flow removing awkward stumps, adding more rock and more mineral soil. Removal of TTF's and trail rails will help drainage. Replanting and gargoyle placement on the trail gives visual and physical flow narrowing the trail tread and reducing environmental impact. Introduction of grade reversal rollers will help with sustainability and drainage.

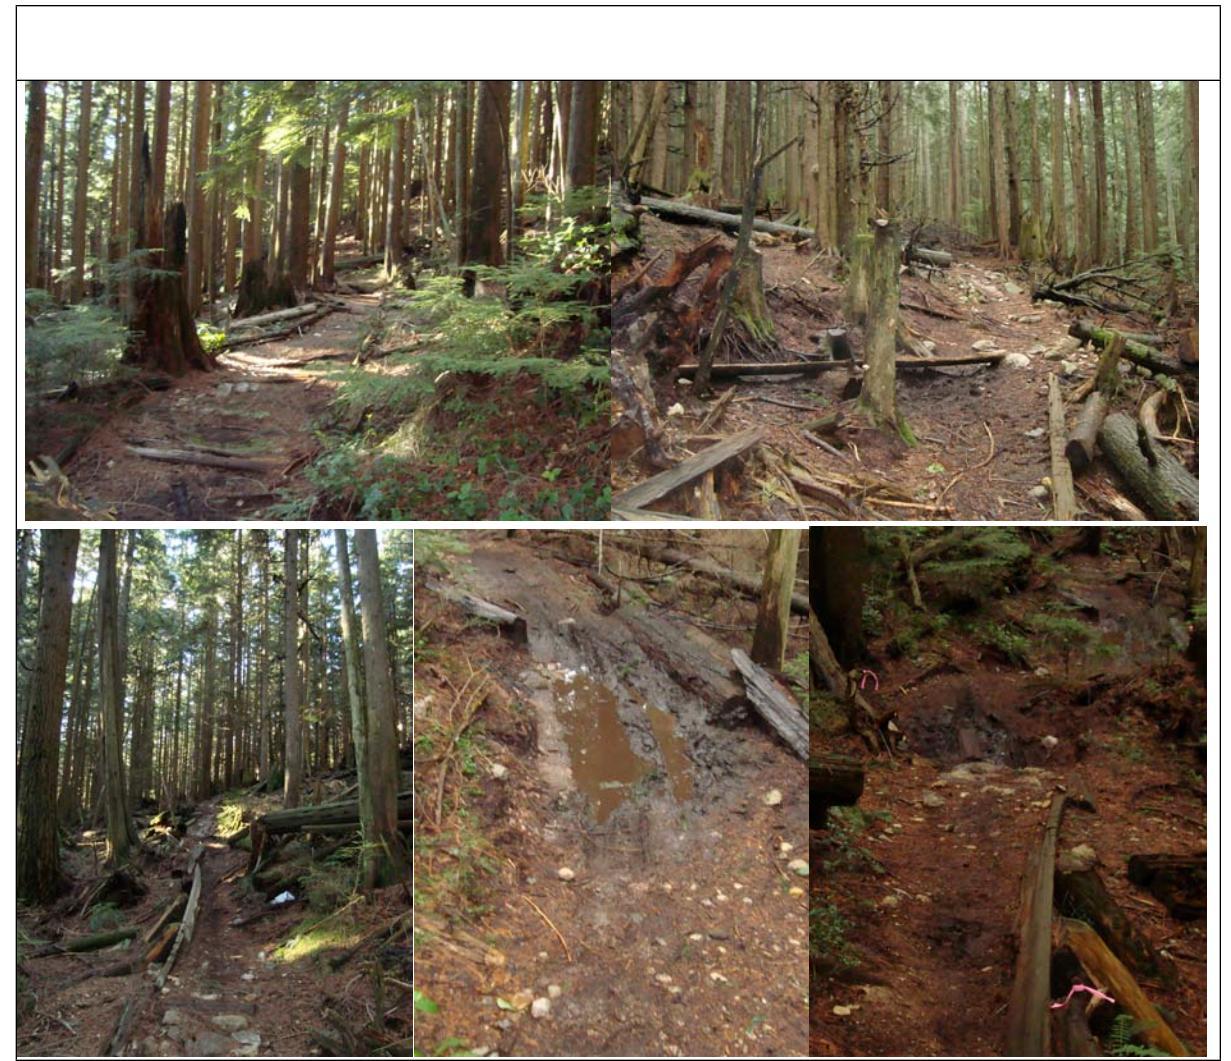
Problem: Lack of alignment and maintenance has expanded the trail tread. Trail railing and bad TTF alignment has caused trail creep and erosion. Soft tread sections with poor drainage. Sections of old skidder road.

Solution: Removal of TTF's and trail rails will help drainage. Replanting and gargoyle placement on the trail gives visual and physical flow narrowing the trail tread and reducing environmental impact. Introduction of grade reversal rollers will help with sustainability and drainage. Short reroute to improve trail experience and move off skidder road.

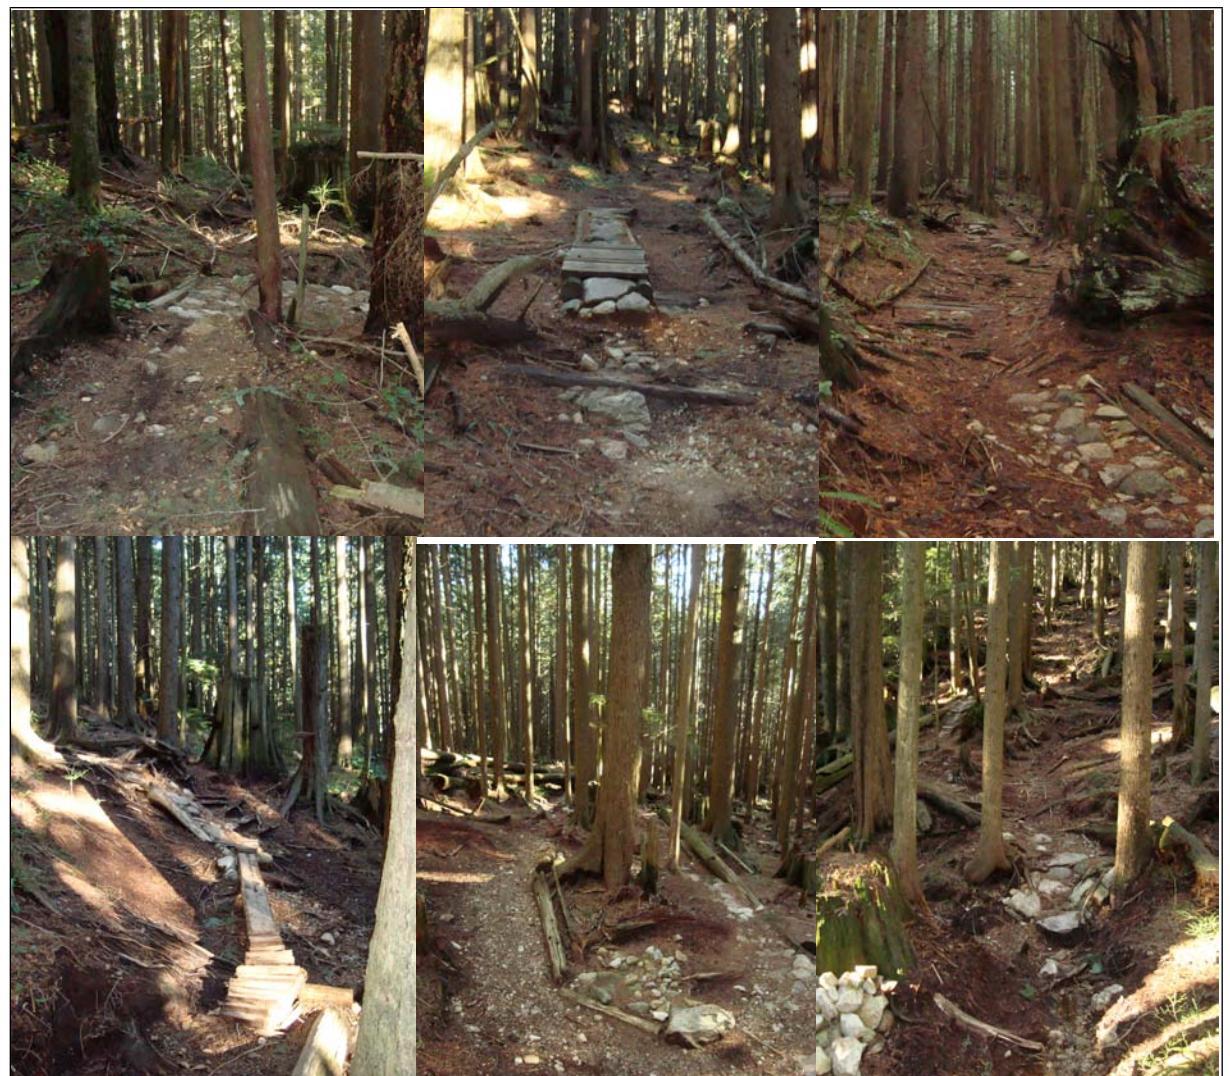
Problem: Poor alignment, long straight section, poor placement of raised rock armouring and TTF, old reroute has drainage issues due to infiltration from water course above. Exposed roots and tight corners.

Solution: Cut back tree on apex and realign entry into corner. Remove raised rock armouring and armour ground to allow water flow over trail. Narrow trail corridor and trail tread introducing gargoyle placement to add flow and corners to slow the rider down. Move trail onto higher ground to help drainage and to avoid low spots. Remove badly aligned TTF's, rock armour and clean up drainage. Realign trail with rock and log corralling. Reroute 50m of trail to change exit of corner to keep the high ground and avoid exposed roots.

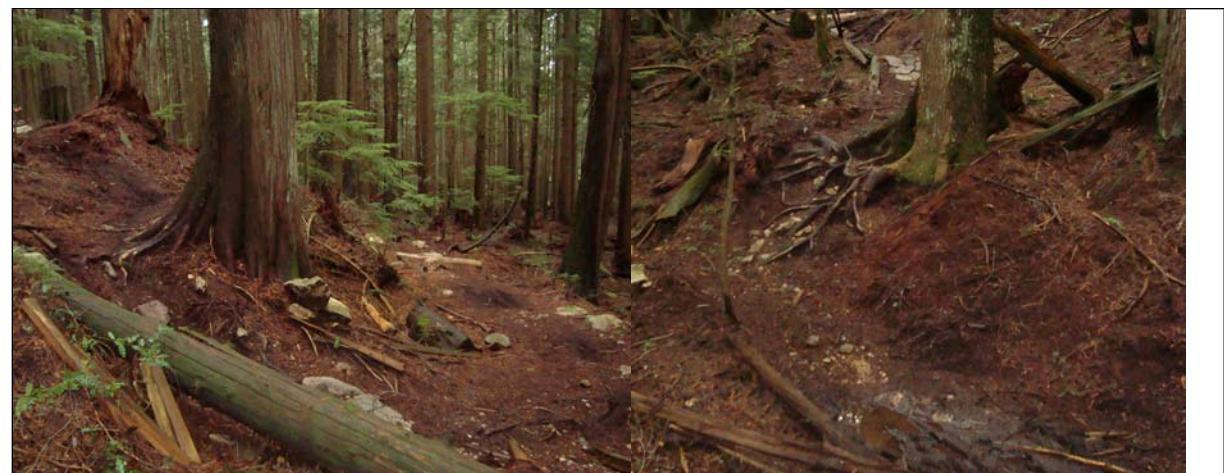
Problem: Exposed roots, trail railing and poor drainage.

Solution: There are several areas along the entire length of the trail that require drainage and ground work to minimize root impact, improve user experience and improve sustainability.

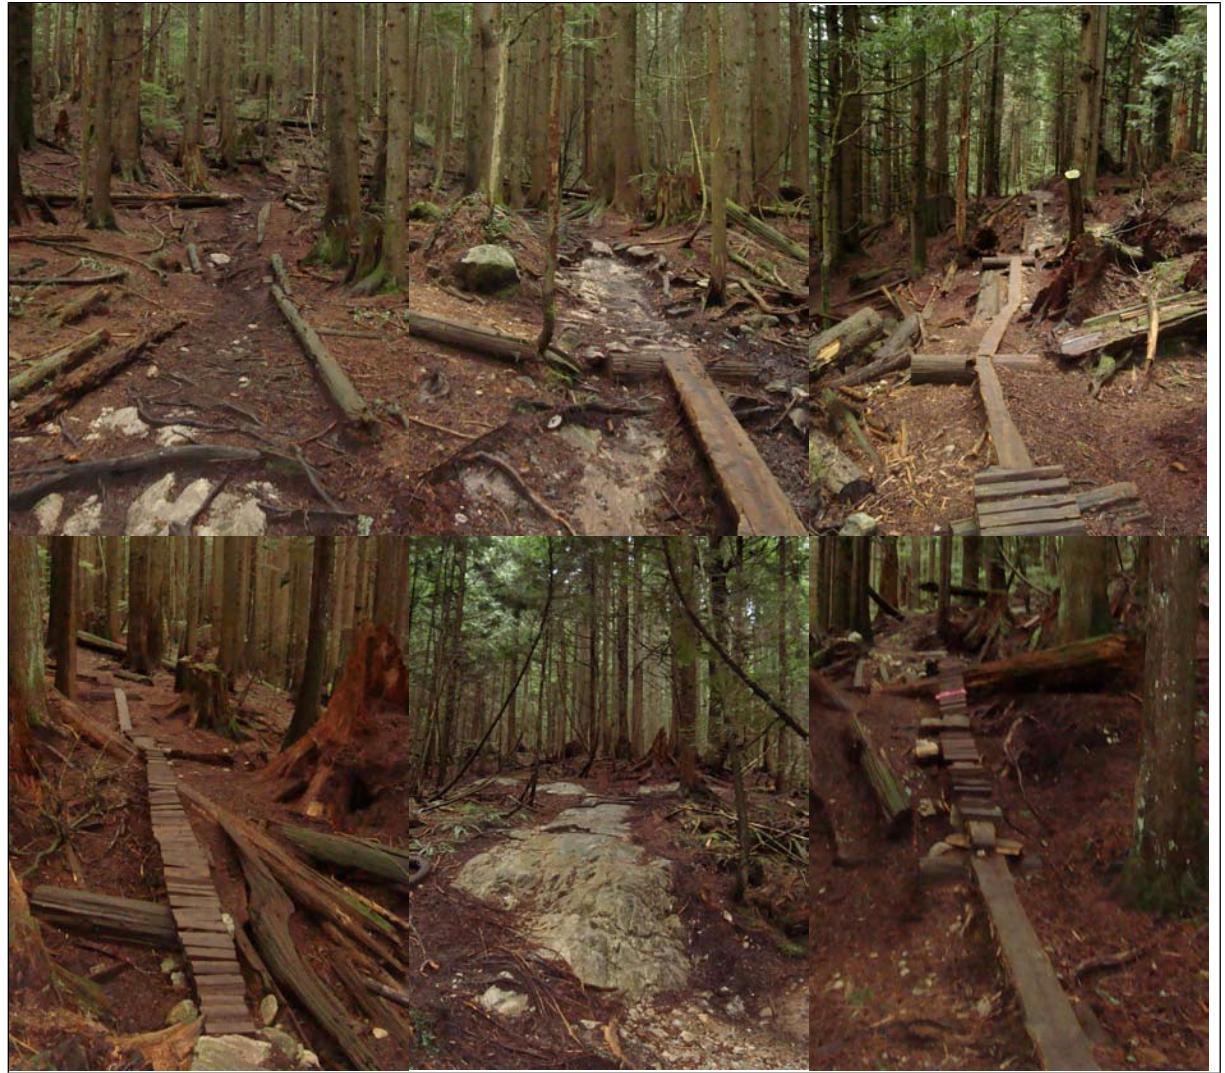
Problem: Straight fast section with soft sections that leads onto exposed ground rock and badly aligned, skinny, rotting TTF's which also leads onto exposed ground rock.

Solution: Coral trail and reroute straight section into forest creating big wide radius turns to control rider speed decreasing in size to line up with ground rock. Replanting and reclamation of old soft trail tread. Remove TTF's and drain. Armour soft sections where TTF's were, creating rollers and grade reversals to control speed and discourage water flowing down trail. Align trail up with second section of ground rock to keep technical aspects of the trail.

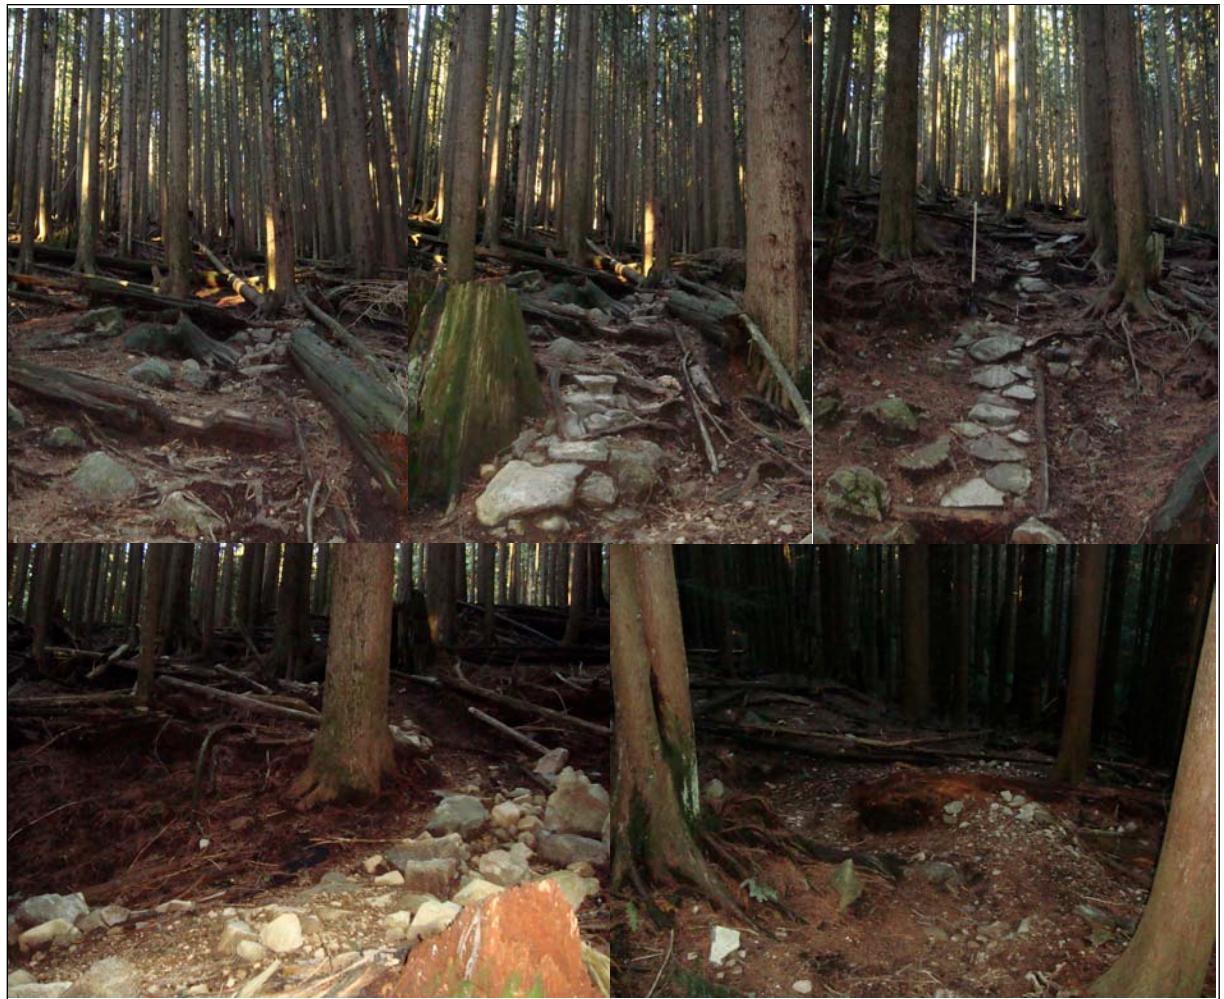
Problem: Fall line deep eroded rut. Poor alignment and severely eroded trail bed, water flowing on trail, advanced steep erosion fall line alignment which cause negative impact on surrounding trees. Very poor corner alignment.

Solution: Reroute trail away from the deep rut and bench cut in new section of trail to align with original switch back corner. Remove second switchback corner and continue trail on side slope until a suitable flat area is reached to switch back trail down again with more bench. Alternatively this whole section could be rerouted down nearby sustainable ground. Remove lower tight corners and make one turn. Completely decommission old line with replanting and reclamation.
