## TRAIL ADOPTION PLAN

2012 Assessment/Work Plan

Trail: Empress By-Pass

## **2012 TAP Trail Assessment/Work Plan Empress Bypass**

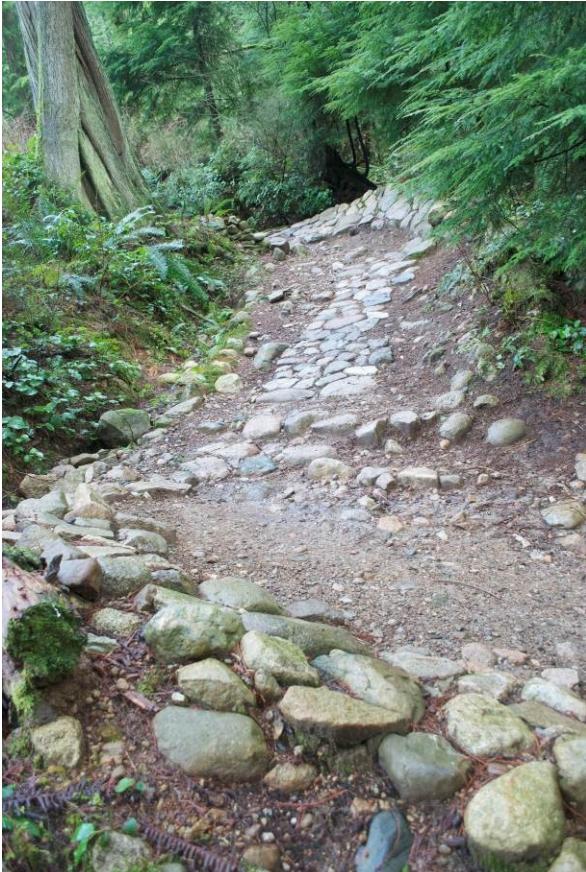
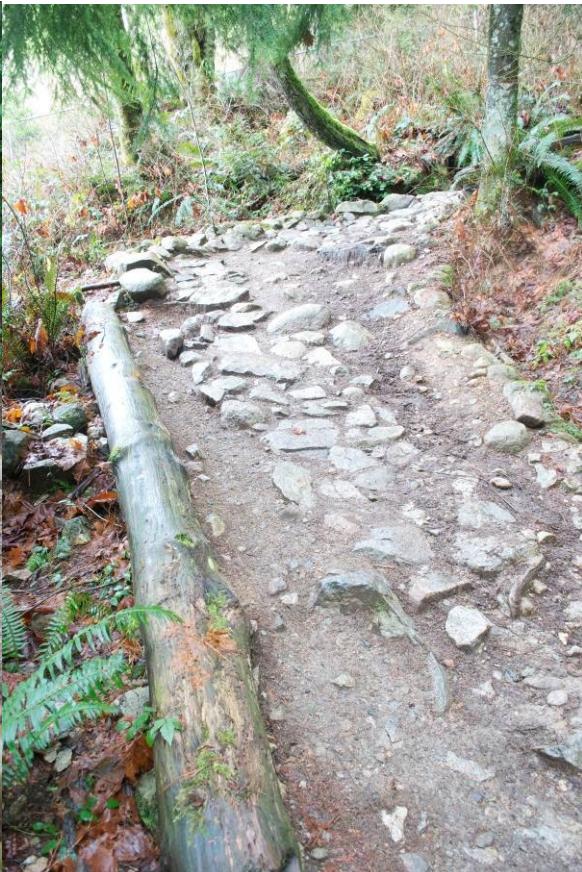
**Describe Problem:** Rocked berms that have eroded out due to rider use and sediment removal from surface run-off. There are 10 berms of this type that will require maintenance.

**Solution:** Holes will need to be filled in, water dispersion will need to be emplaced above and within the switchback/berms. Drainages on the sides of trails will need to be cleared.

**Approximate timeline:** 2 trail days.

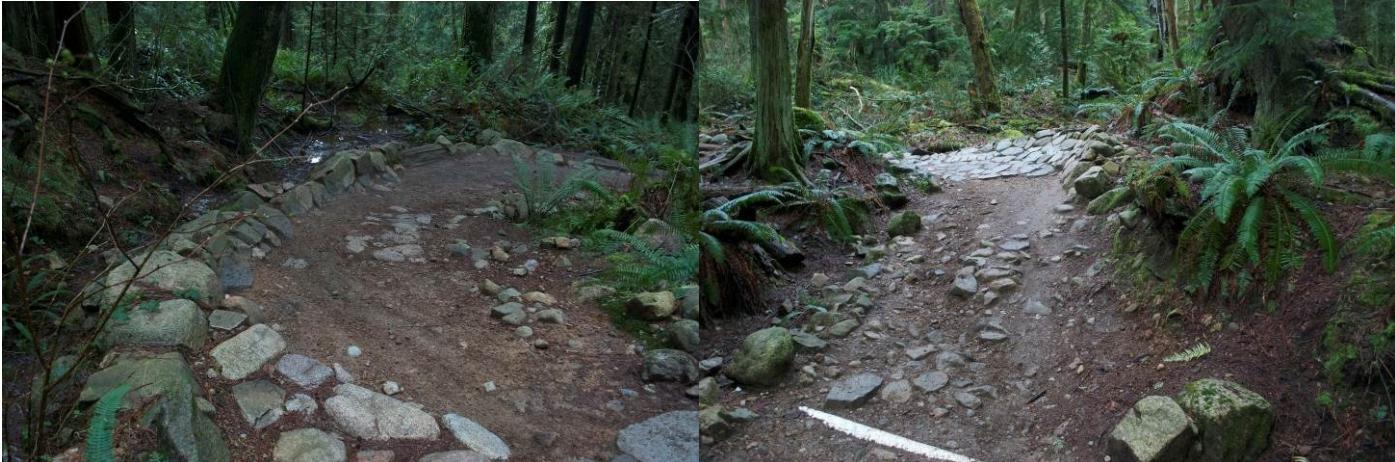
Describe Problem: A number of the larger berms are poorly aligned, not round making sharp angles. The berms are also incomplete, not finishing off onto the ground.

Solution: Trail needs minor realignment and berms need to be finished to the ground. Water dispersion will need to be put in place above and within the berms

Approximate Timeline: 2 day

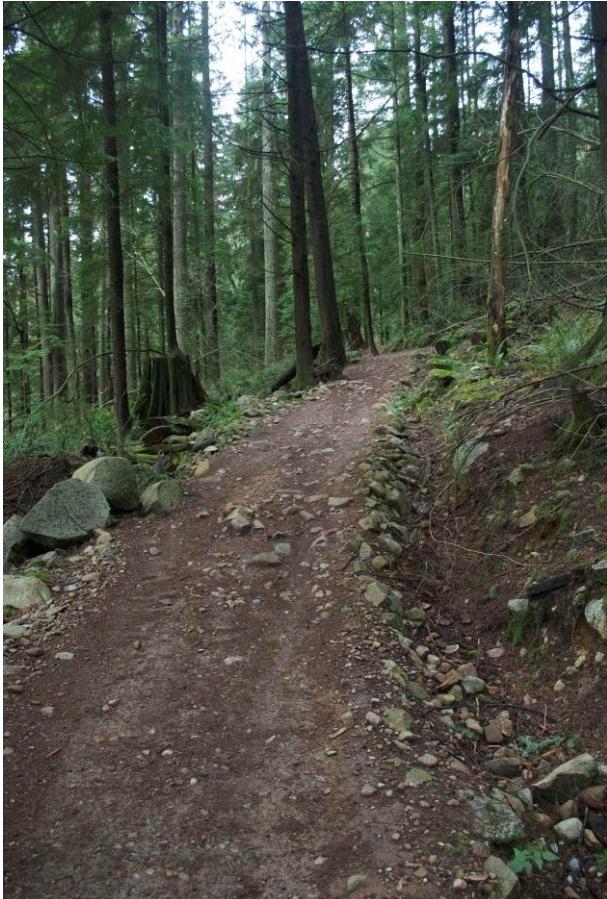
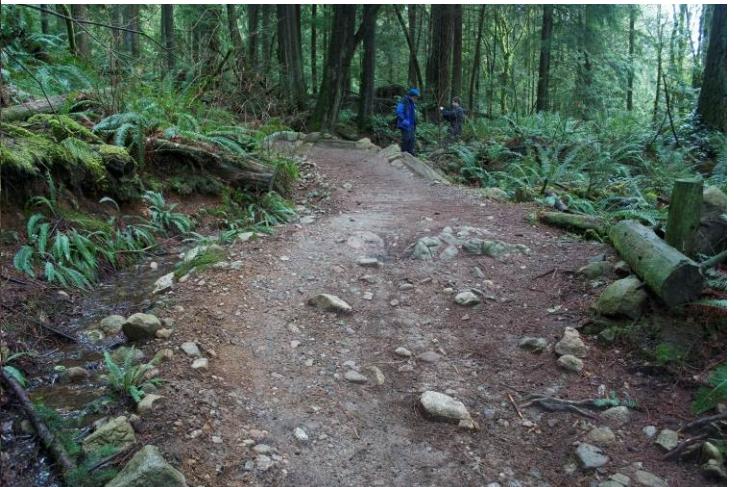
Describe Problem: high-speed area above blind junction with Empress (left). Trail erosion on trail sides and lack of ecologically balanced vegetation in area. Widened trail base does not give rider clear visual line of alignment.

Solution: Re-vegetate trail sides. Narrow trail with vegetation. Install turns and cambered minor switchbacks in straight-aways to implement speed control.

Approximate Timeline: 1 day

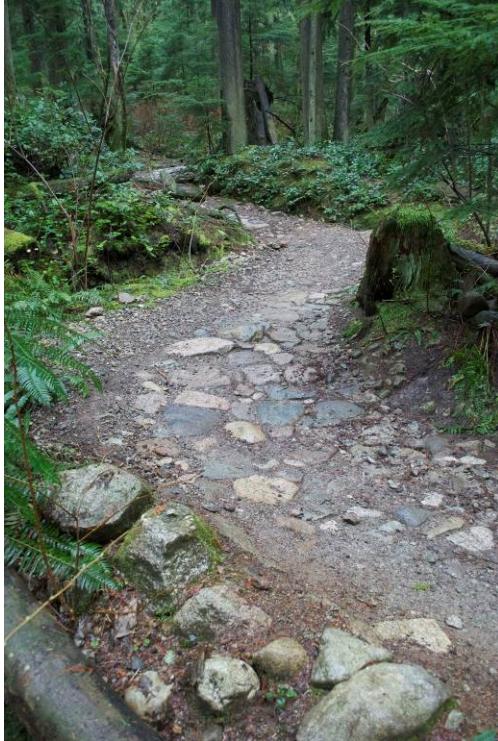
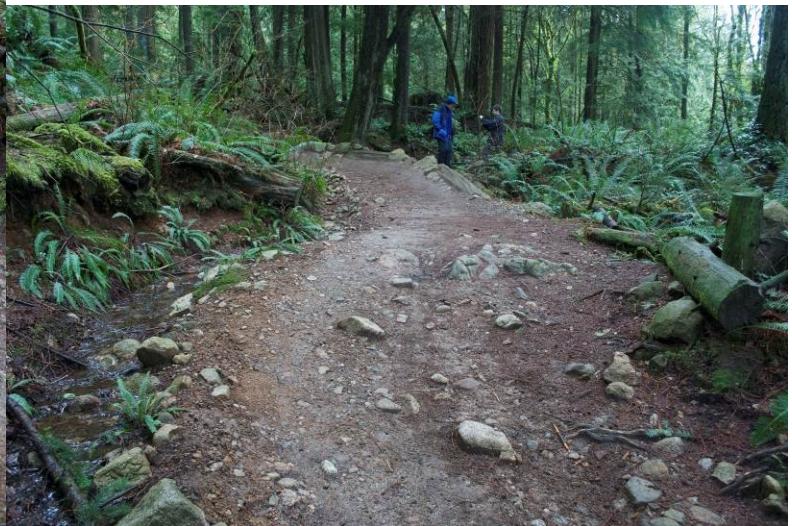
Describe Problem: Multiple areas of widened trail bed and water run-off on trail bed surface.

Solution: Narrow trail with re-vegetation and water dispersion throughout trail.

Approximate timeline: 2 trail days.

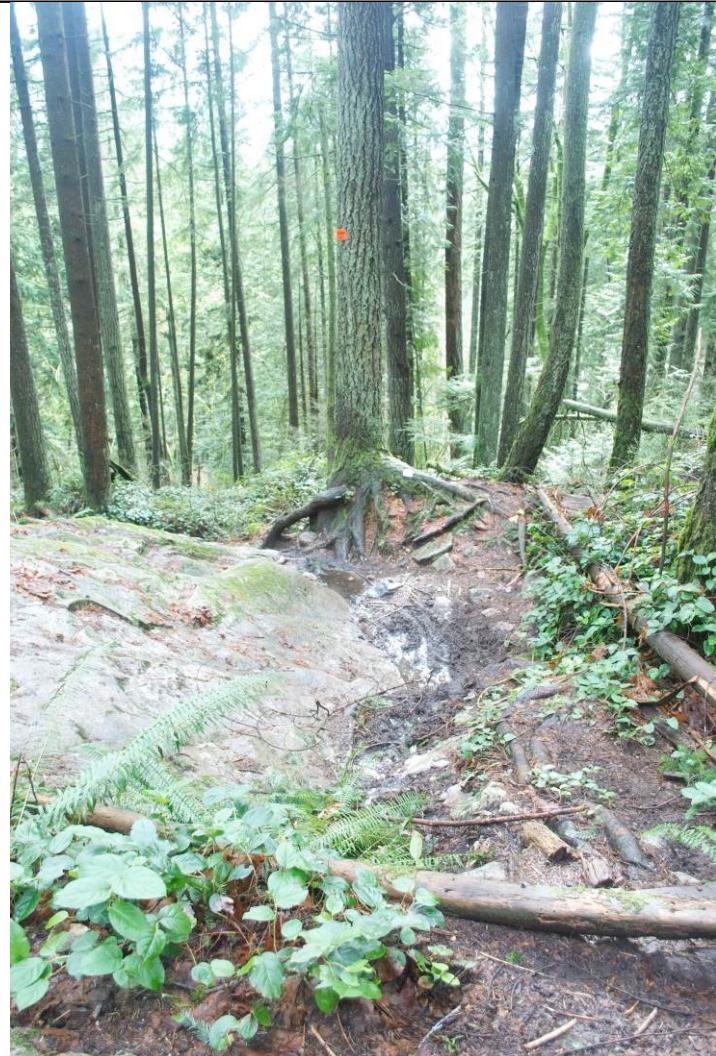
Describe Problem: Poor drainage in low areas.

Solution: Clear out drainage, raise trail bed.

Approximate Timeline: 1 day

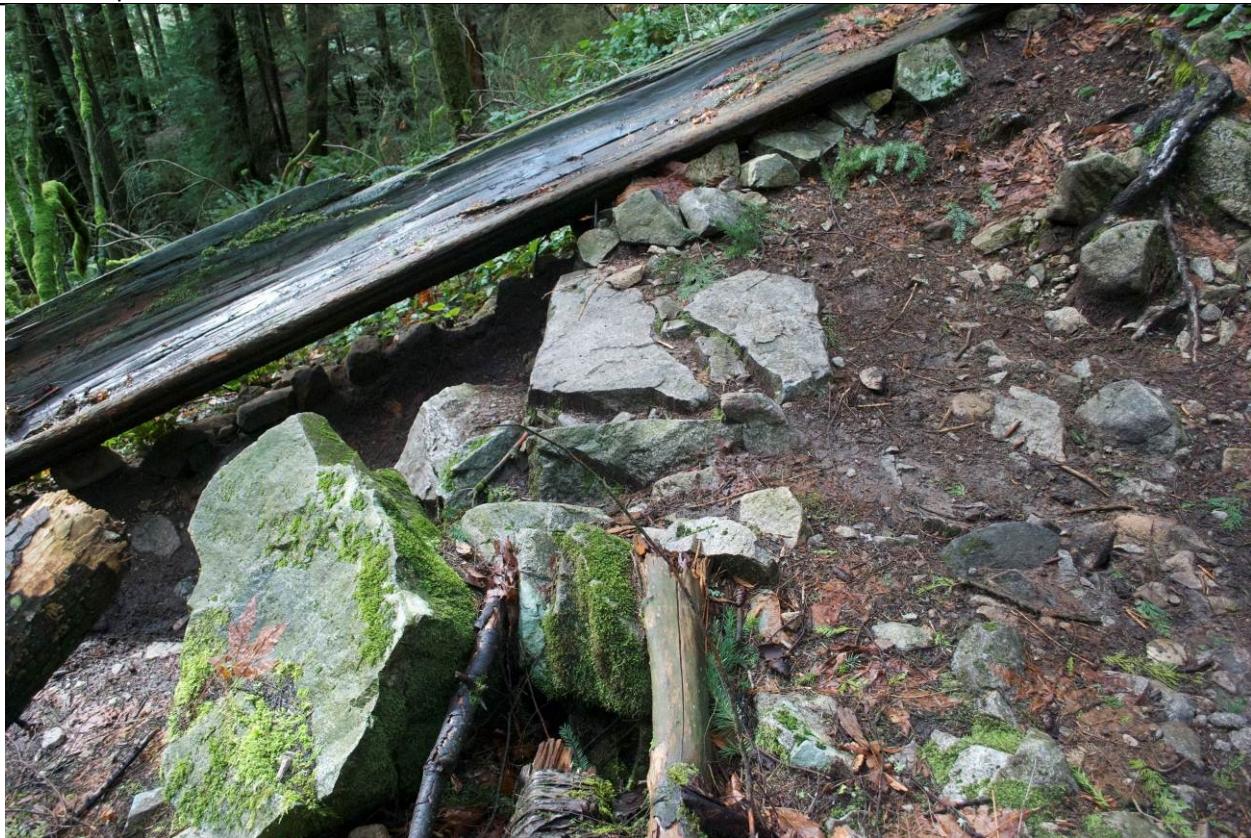
Describe Problem: Rockwork exposed, entrance to log ride not working

Solution: Minor rockwork to re-establish turn and entrance to log ride. Roof tiling to provide traction in log ride.

Approximate Timeline: 1 day

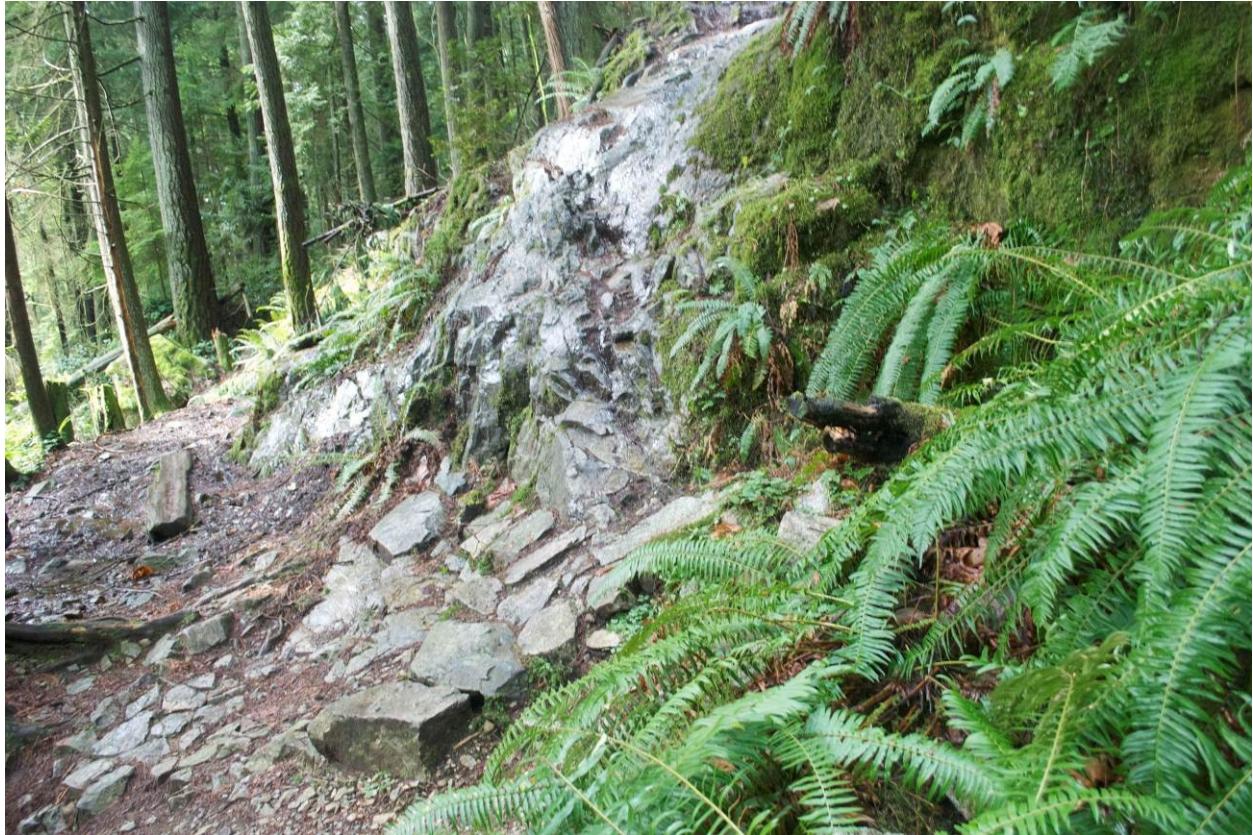
Describe Problem: Rockwork coming loose at exit of rock roll.

Solution: Minor rock work and dirt work to clean up transition at bottom of rock roll.

Approximate Timeline: 1days
