2012 TAP Trail Assessment/Work Plan

Trail: Executioner

Land Manager: DNV

The Executioner trail on Mt. Fromme is an old mountain bike trail that was combined with the lower half of Bitches Brew trail by the DNV Trail Crew in 2011. Re-alignments made to the trail have settled in and the increase in traffic since the work was completed has resulted in numerous drainage and trail surface issues. The goal for 2012 is to continue on with the DNV Trail Crew's work and remedy these issues to bring the trail to standard.

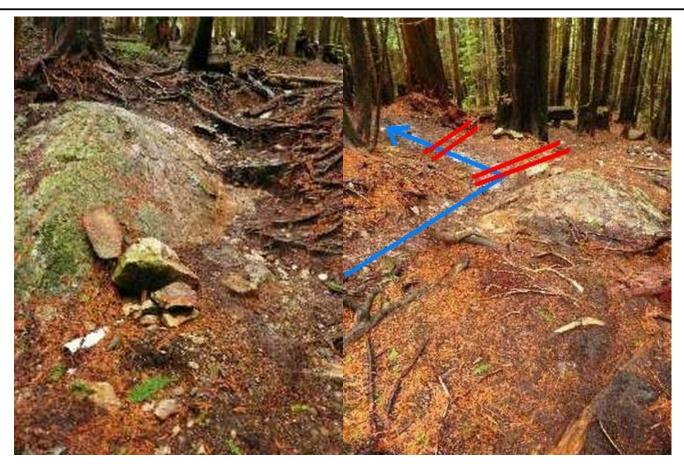
Describe Problem: underground water is seeping onto the trail. Water is passing over a drainage pipe (as seen in the left pic) and continuing down the trail (as denoted by blue arrow). Cedar roots at top of rock face are exposed (as seen in foreground of right pic).

Solution: Create a new drain below the rock face, and a grade reversal further down the trail (denoted by double red lines).

Crib the left side of the trail leading to the top of the rock, fill with rock & mineral dirt to protect cedar roots.

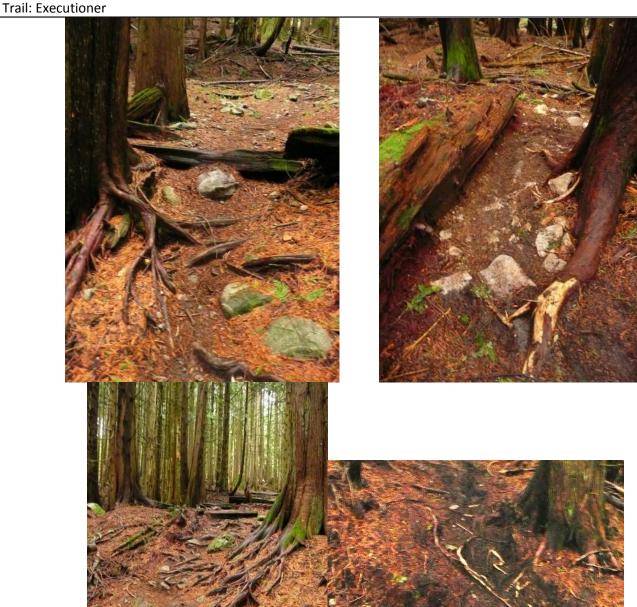
Describe Problem: tree roots, mostly Cedar, are exposed and being damaged on old & new alignments of the trail Solution: build rock and mineral dirt over top of roots, use cribbing where necessary to create a raised trail bed

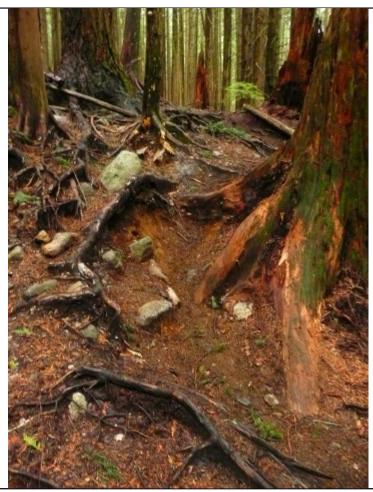
Describe Problem: Downhill corner is eroding around old stump

Solution: Use rock and mineral soil to bring trail up to grade, berm corner to reduce braking and improve flow

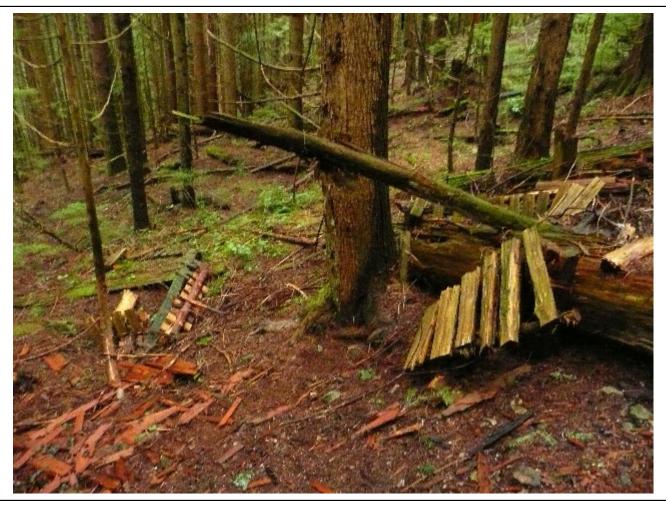
Describe Problem: old structures have been discarded off the sides of the trail

Solution: remove nails and bury wood remains - use to fill in holes dug for mineral dirt, naturalize after with ferns and other flora.

Use some sections as "trail heritage" installments to commemorate the history of the trail - ideas include creating naturalized gardens around sections of ladder ramps in unobtrusive areas. To be discussed with DNV.

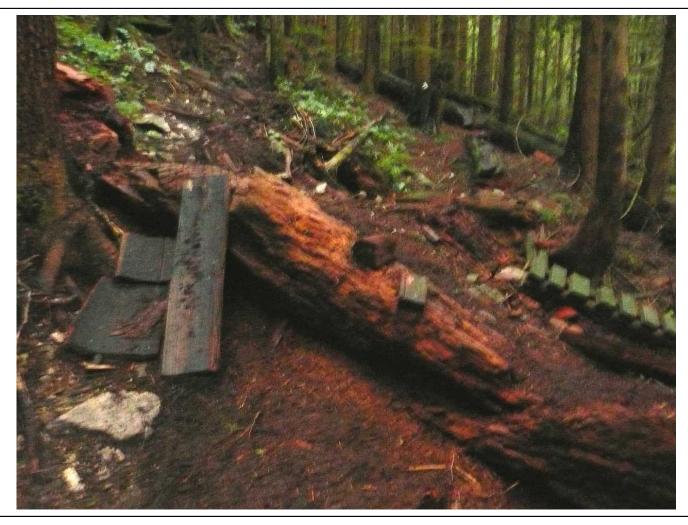
Describe Problem: this is a steep section leading into a roll down a wood slab off an old log which can be difficult to line up and there is no easier alternate line.

Solution: This is a technical trail feature that adds to the experience of the trail and ideally would be kept, with an additional wood slab added to the left side (as viewed here) to reduce risk. This is the only wooden TTF on the trail and the use of burnt cedar with added cross hatching for grip will last for many years.

Alternative solution: Remove the entire log, returning the trail to surface grade, but is not the preferred option. A ride-around option to the right (as viewed here) will not work due to the alignment of the trail continuing on below. **Consultation with DNV as to the preferred solution is required.**

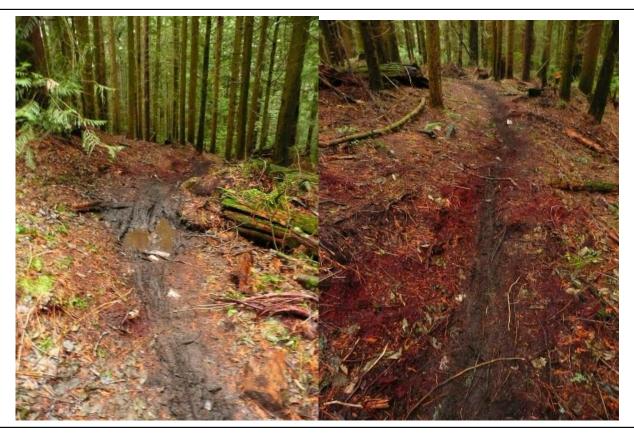
Describe Problem: new trail alignment from 2011 is on organic soil creating mud and drainage issues

Solution: remove organic layer, build up with mineral dirt, create drainage

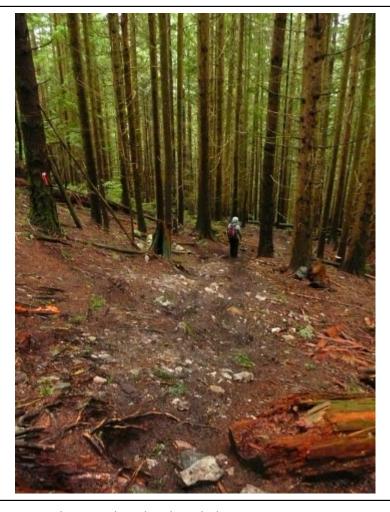
Describe Problem: fall line section is being widened and eroded

Solution: the original line continues to the left, high side of the tree with the flagging, then turns right and down to where the person is standing. Block off fall line section and reinstate the original line, will include cribbing in a benched section to cover the roots in the foreground, continuing across to the left.
