2012 Assessment/Work Plan

Trail: Dreamweaver

Landowner: DNV

This trail is an all mountain trail that traverses across Fromme. The mountain bike specific section of DW begins at the BP and makes its way down to Boundary where it joins to exit on Braemar. The trail has drainage issues in several spots and significant sections where alignment is close to trees and with heavy use has exposed root sections. Other sections are slumping and need retaining. Ground work and realignment are the prime tools to rectify these issues. There are many areas in an advanced state of erosion which have experienced heightened use since the consolidation of Executioner and Bitch's Brew in 2011 which has increased ridership significantly. Arc'teryx has committed to minimum 6 trail days, possibly 8.

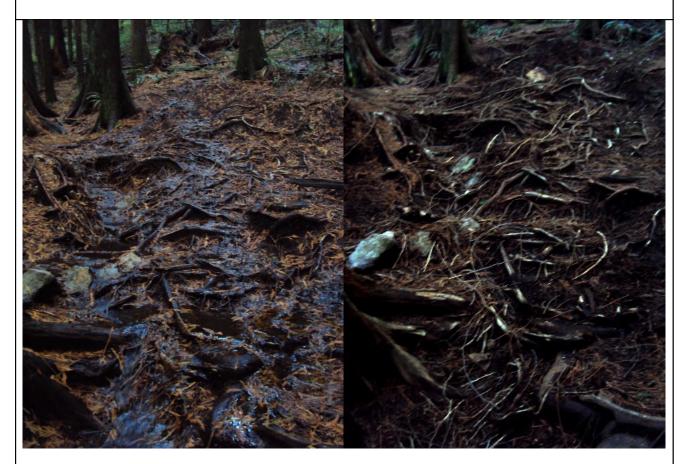
Describe Problem: Braided creek above runs onto eroded trail bed in several spots and is trapped for approximately 100+ feet. The area has been severely eroded and the alignment runs close to trees, therefore exposing root systems.

Solution: Trail needs realigned for proper drainage and to lessen impact on trees. Bench landscape approximately 50 feet above trail will alleviate drainage issues and is above braided creek bed. Reclamation for old trail bed.

Approximate timeline: 2 trail days.

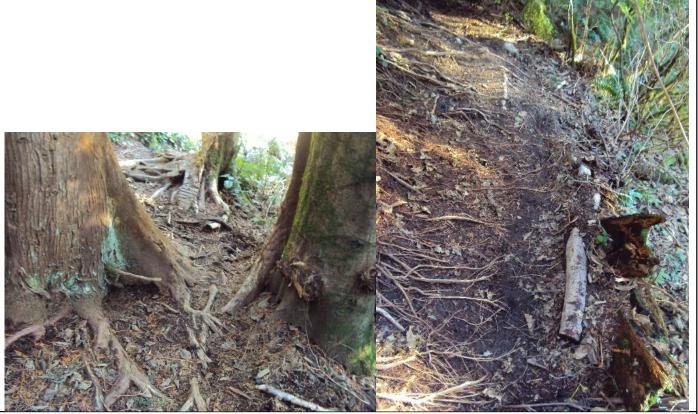
Describe Problem: This section is difficult to navigate and negatively impacts root systems of mature cedars. Trail is poorly benched and is slumping.

Solution: Trail needs realigned above mature trees and properly benched to increase sustainability and minimize impact on trees. Old trail bed needs reclamation.

Approximate Timeline: 1 day

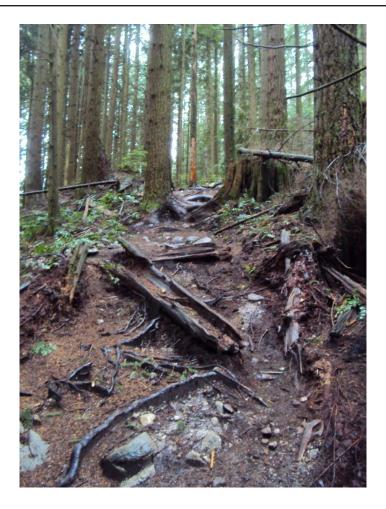
Describe Problem: Advanced erosion-fall line alignment. 100 foot section. Trail is very close to mature trees and impacting root system.

Solution: Realign on left of photo to a rolling contour bench to improve sustainability, minimize long term maintenance and alleviate environmental impact while improving user experience.

Approximate Timeline: 1.5 days

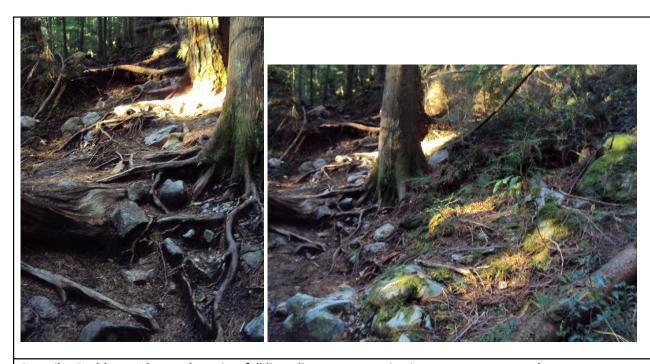
Describe Problem: Advanced erosion-fall line alignment-negative impact on mature cedars.

Solution: Realign 50 feet of trail to improve sustainability and alleviate environmental impact. Reclaim old section with replanting/check dams. Planned reroute is visible in second pic on high side of trees.

Approximate Timeline: 1 day

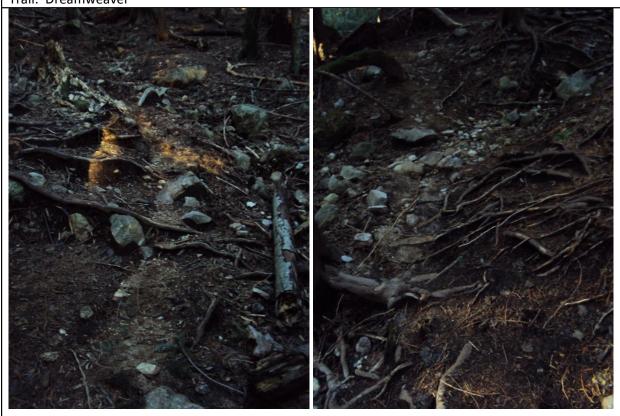
Describe Problem: 1. Drainage 2. Erosion This section of trail borders a water course and goes to the low side of trees. Low section of trail suffers from poor drainage due to infiltration from water course above.

Solution: Trail bed needs built up with retaining wall and the water course needs clarified with an armoured crossing and slight route alteration to high side of trees.

Approximate Timeline: 1 day

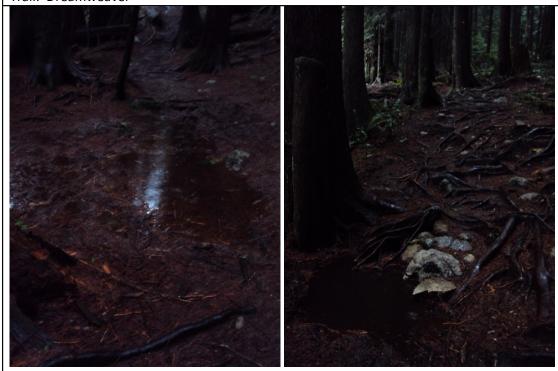
Describe Problem: 1. Drainage 2. Erosion

Solution: There are several areas along the entire length of the trail that require drainage and ground work to minimize root impact, improve user experience and improve sustainability.

Approximate Timeline: 2 days
