TRAIL ADOPTION PLAN NSMBA

2011 Work Plan

Trail: Circuit 8 Trail **Landowner:** Metro Vancouver

NSMBA TAP Trail Assessment/Work Plan

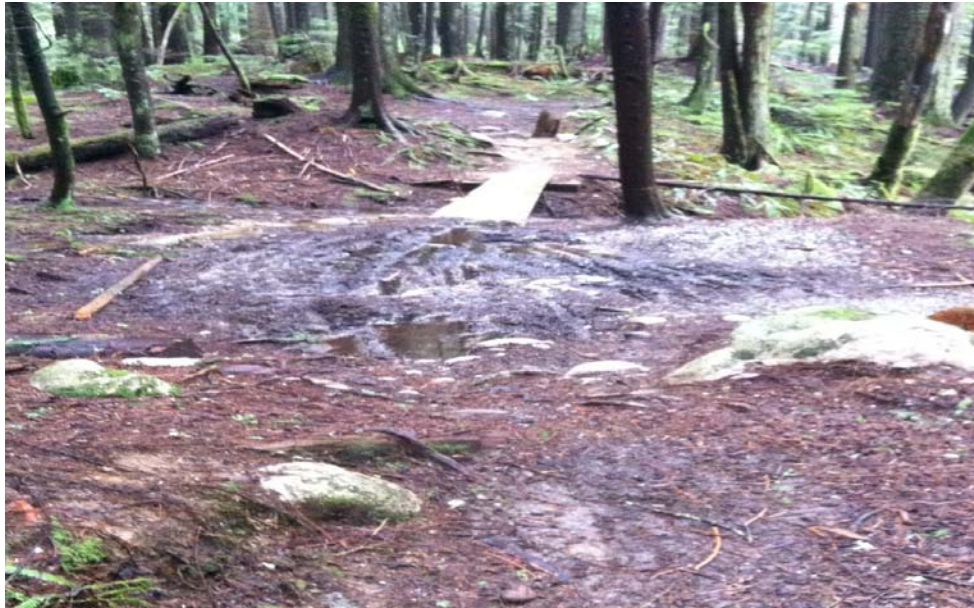
Describe Problem: The current bridge was replaced during a very dry summer when it was hard to assess the water flow on the approach to the bridge. The approach has now become a giant mud puddle with many different lines forming as users try to avoid the mud.

Solution: The water cannot be diverted, so the best solution is to extend the current bridge over the wet area. The extended bridge will be built using milled stringers, while footings and rungs will be sourced on site.

Tools/Supplies Required: 40 feet of milled 3x6 or 4x6 stringers, ¼ box of 6 inch spiral galvanized nails, 3 hatchets, 5 hammers, 2 mattocks, 1 shovel, 1 bucket

Supplies requested from Landowner: Milled 4x6 or 3x6 cedar stringers. Enough to build at least a 40 foot bridge.

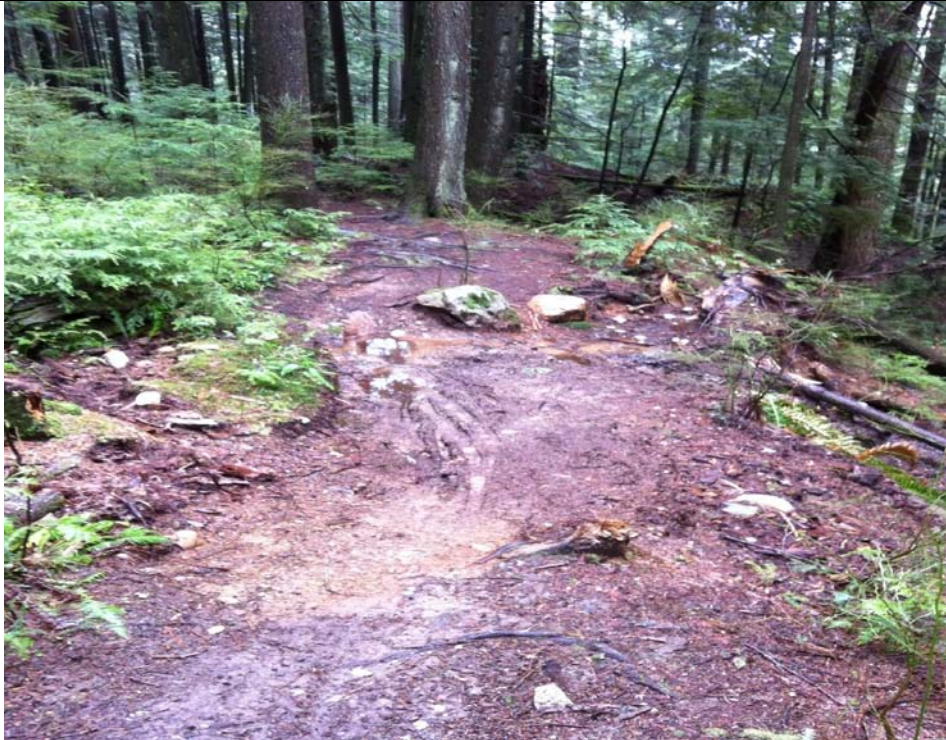
Describe Problem: This section is wet almost all year long as it is a drainage flow. The mud is really soft and really sucks up tires and shoes if you step in it.

Solution: This section needs a bridge built over it to keep trail users out of the mud and water. A bridge will be built using milled stringers and footings/rungs sourced on site.

Tools/Supplies Required: : 40 feet of milled 3x6 or 4x6 stringers, ¼ box of 6 inch spiral galvanized nails, 3 hatchets, 5 hammers, 2 mattocks, 1 shovel, 1 bucket

Supplies requested from Landowner: Milled 4x6 or 3x6 cedar stringers. Enough for at least 40 feet of bridge.

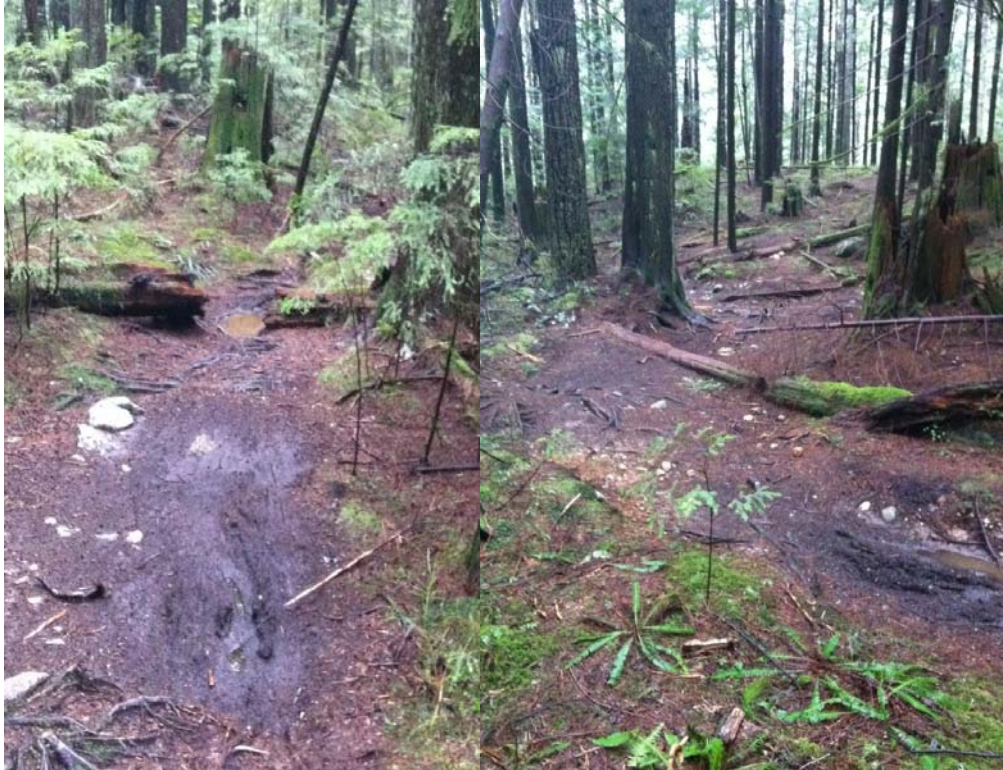
Describe Problem: This section is a straight and constant downhill that turns and becomes a braided out area with an awkward log in the middle of the trail and puddles in many places. There is no defined line and no easy way to fix the multiple problems that this area has.

Solution: After some discussion it was decided that the best way to manage this section was to re-route it. Just prior to the straight downhill section there is a decent slope that will allow for a bench cut trail with appropriate side slope.

Tools/Supplies Required: 4 mattocks, 2 macleods, 3 shovels, 3 buckets, 2 pry bars

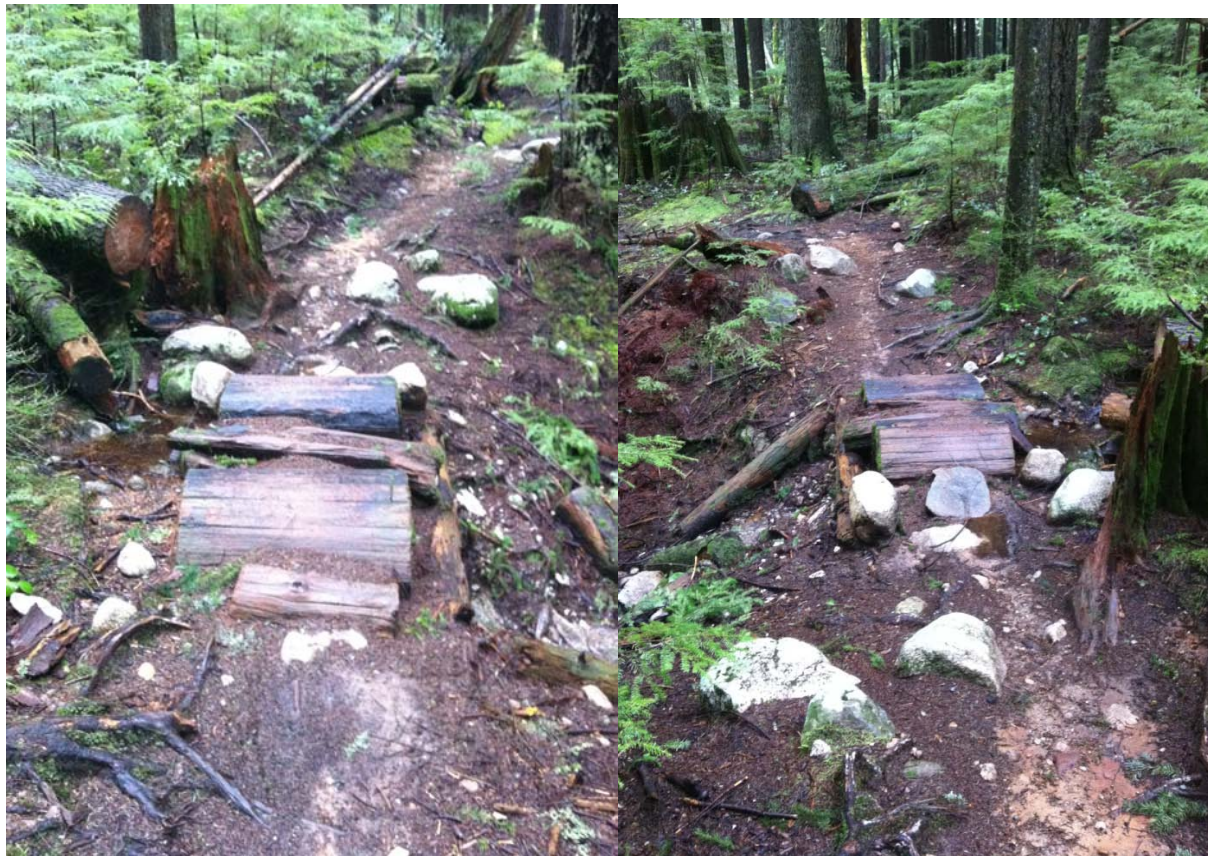
Describe Problem: This old school approach to a creek crossing is extremely awkward and a very difficult TTF for novice riders. It is also obstructing the normal flow of water under it.

Solution: The old structure will be removed and replaced with a ladder bridge that completely spans the drainage flow. Milled stringers will be used, with footings and rungs sourced on site.

Tools/Supplies Required: 40 feet of milled 3x6 or 4x6 stringers, ¼ box of 6 inch spiral galvanized nails, 3 hatchets, 5 hammers, 2 mattocks, 1 shovel, 1 bucket

Supplies requested from Landowner: Milled 4x6 or 3x6 cedar stringers. Enough for at least 40 feet of bridge.

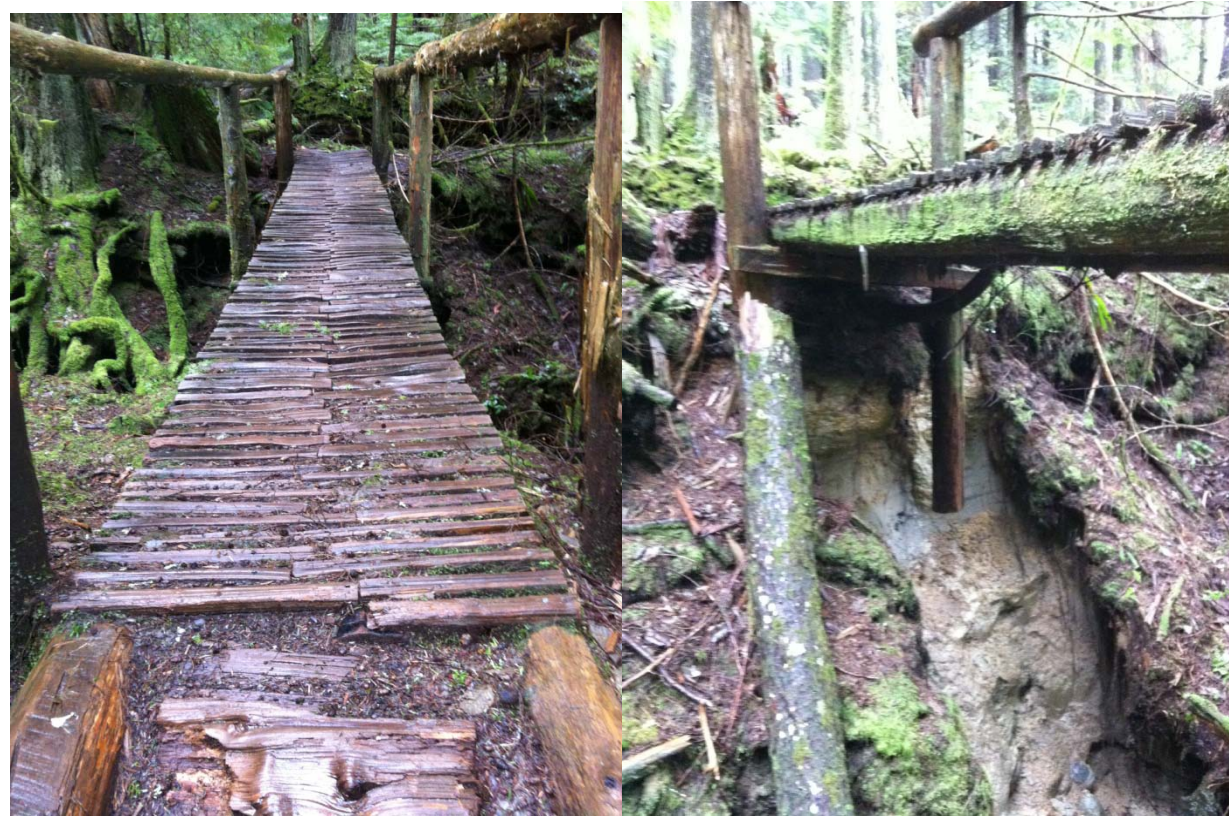
Describe Problem: This old bridge is a classic, however the canyon that it is built has widened and washed away the ground underneath one of its supports. The other support is close to being undermined as well and the entire bank that it rests on will eventually fail, resulting in loss of the bridge.

Solution: The current position of the bridge is unsuitable due to the unstable nature of the canyon's banks. The bridge should be relocated further upstream in a more stable location. This would require a major shift in the trail alignment and will require further consultation with LSCR staff to determine the best solution.
