2012 Assessment/Work Plan

Trail: Circuit 8

NSMBA TAP Trail Assessment/Work Plan

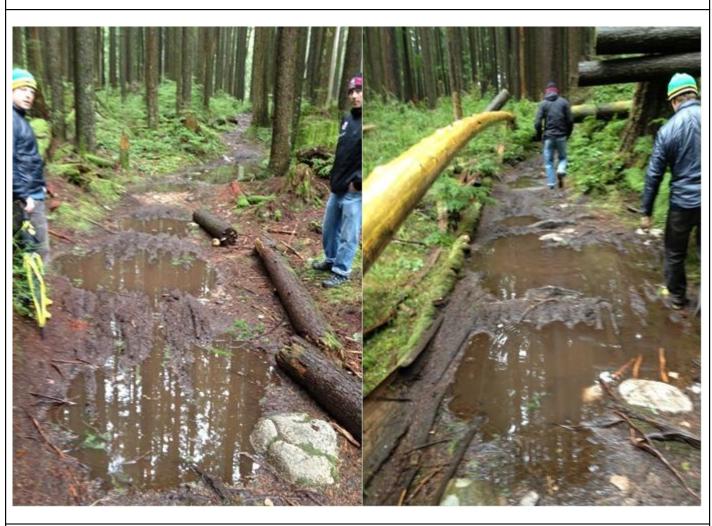
Section 1- Near beginning

Describe Problem: Large puddles with no drainage

Solution: Remove the organic material and dig ditches on both sides of the trail. Elevate the trail bed using mineral soil and crown to allow drainage.

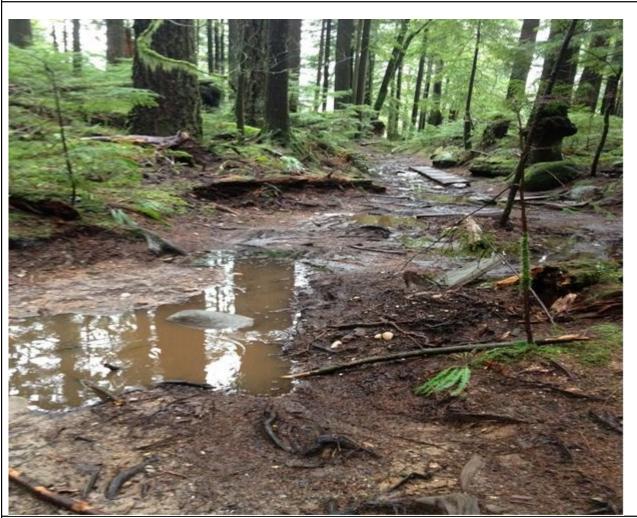
Section 2- In the middle

Describe Problem: This area is just on the other side of a ladder bridge which crosses a swampy area. The area is low lying and is filled with large puddles.

Solution: There is a potential re-route on the left hand side of the picture that could bring the trail up on a small ridge. Alternatively, a crib could be made against the left hand bank and then filled in with mineral soil. This would be labour intensive but would avoid further disturbance to the surroundings.

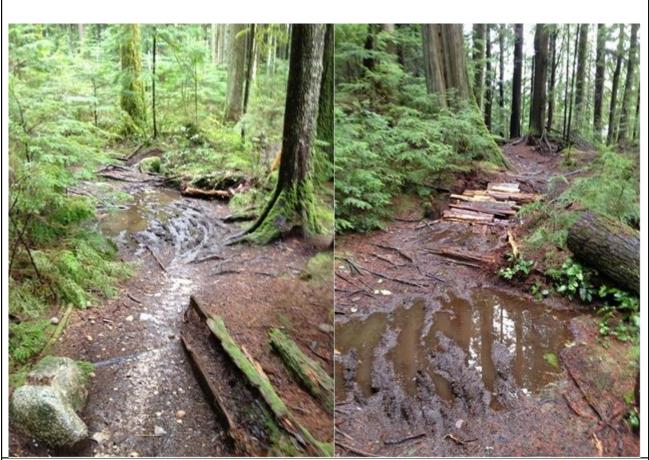
Section 3- North End

Problem: The area on both sides of the long bridge is filled with large puddles and muddy organic matter. It is perhaps the worst area on the trail and a major reason why people avoid the North loop of the trail. **Solution**: It may be possible to dig out some of the organic matter and dig ditches to drain the water, but some of the areas will likely require ladder bridges to span the worst sections.

Supplies requested from Landowner: Sixteen 8 foot 4x4 beams
