2012 Assessment/Work Plan

Trail: Lower Griffen

NSMBA TAP Trail Assessment/Work Plan

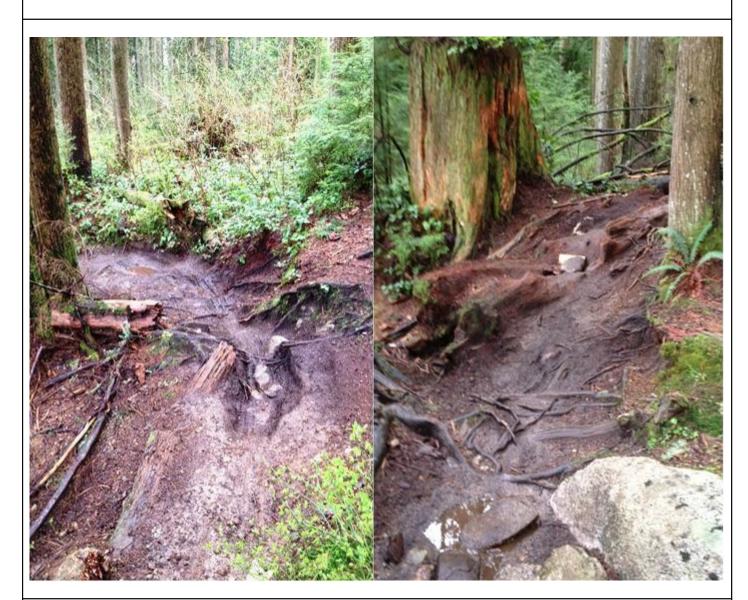
Section 1- Organic trail bed

Describe Problem: Puddles with no drainage. Trail bed is organic material which makes it soft and unsustainable. **Solution**: Remove the organic material and fill in with mineral soil. Dig drainage.

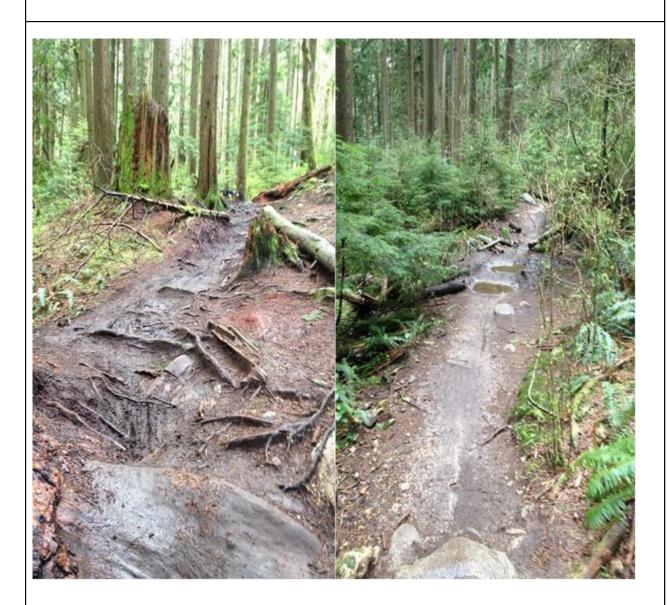
Section 2- Just before and after intersection with Immonator

Describe Problem: Trail bed is organic material which makes it muddy and allows puddles to form.

Solution: Remove the organic material and replace with mineral soil. Dig drainage

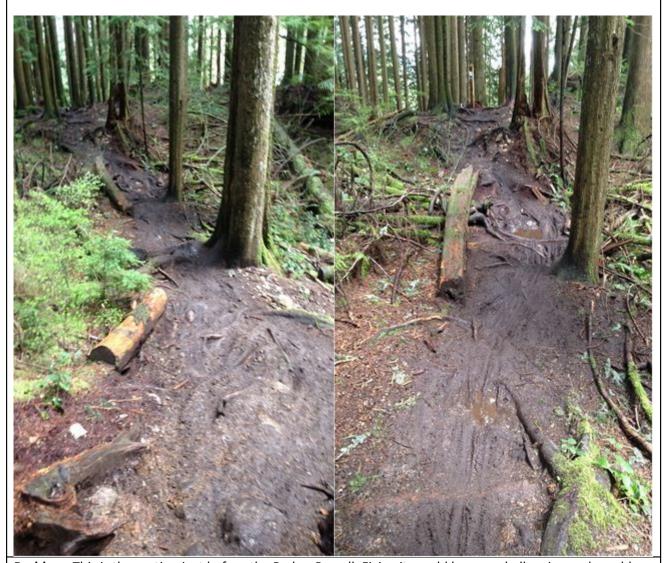
Section 3- Near Baden-Powell

Problem: This is the section just before the Baden-Powell. Fixing it would be very challenging and would continue to impact the root systems of the trees.

Solution: The best option would be to re-route the trail earlier to fix the alignment.
